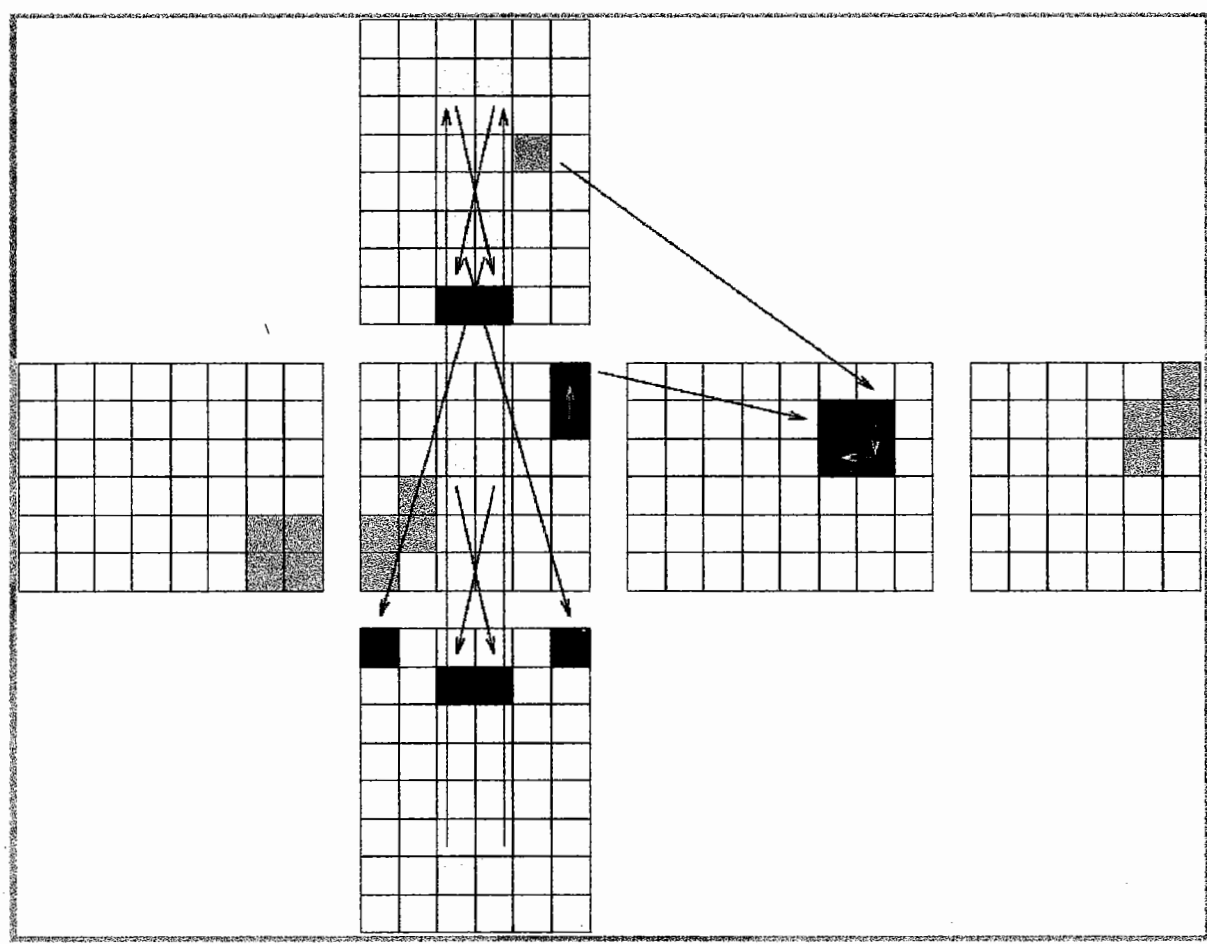
PMT replacement for the 2nd test

- : Gray — 12 PMTs leave
- : Yellow → Red — 8 PMT. leave after position change.
- (Black) : F30, R37 didn't work at 1st PMT test. will be re-checked at the different position.
- : Green QE < 10% will be checked at the different position.

T31 ~ T34 : The results between PISA and LP were different about QE.

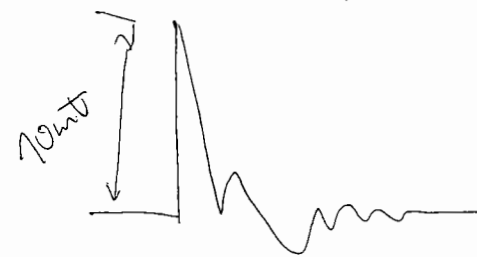
R7

Strange signal at the splitter input

← positive signal

Signal cable soldering on the base may be wrong? HV off

R7. At the feedthrough exit. PIN collapsed!! → fixed somehow.
