Rebottling xenon.

Check of the connection of the LP signal cables

Pulse tube refrigerator test.

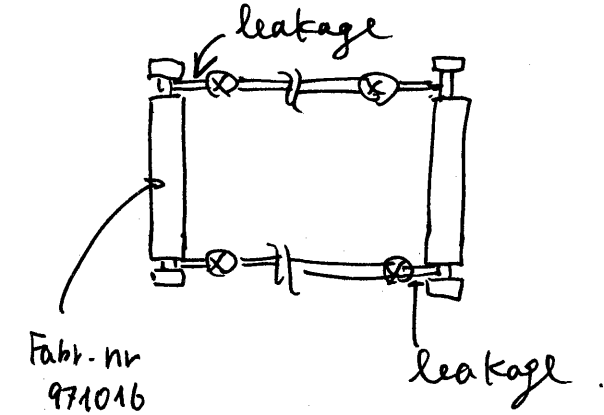
▷ Large leakages found between Oxisorb and swagelok valve
⇒ swagelok valve should be kept closed
(Oxisorb is not used for the moment)

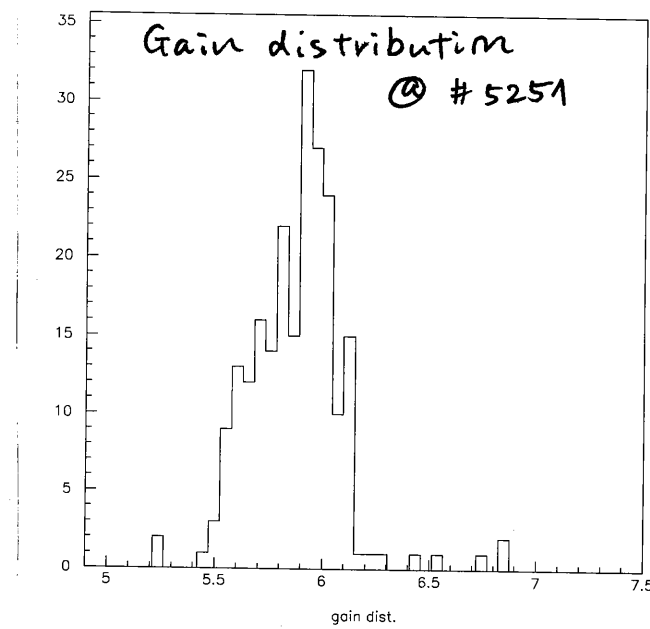
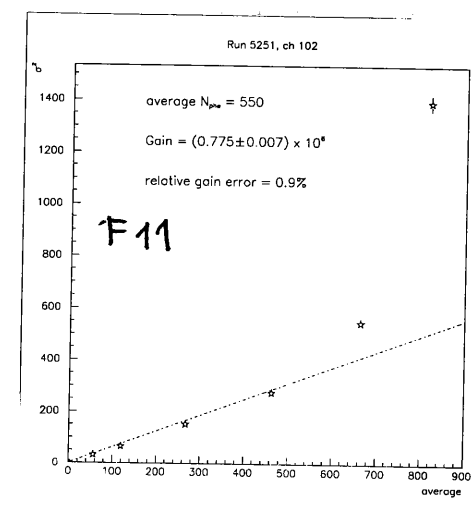
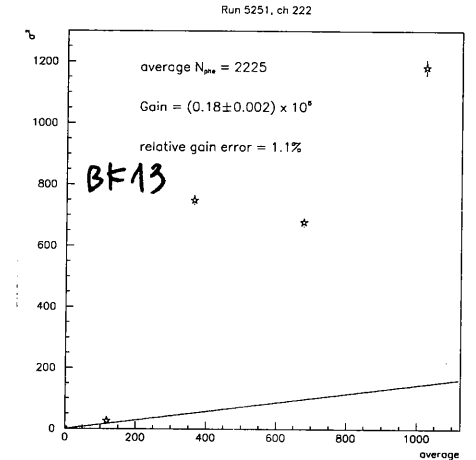
Faulty channels @ LED ADC spectrum

ADC #	Burndy	Feed thru
F14	31	X	O
BT0	39	O (low gain)	O (low gain)
L4	61	HV trip	$\rightarrow I = 90\mu A @ 100V$
F11	102	very low gain	very low gain
BT19	119	HV trip	$\rightarrow I = 70\mu A @ 100V$
T23	120	O (low gain)	O (low gain)
L34	165	X	X
R37	186	X	X

strange behaviour \Rightarrow in F11 & BF13

L4	HV trip	(HV can be applied up to feed thru)
BT19	"	
L34	No signal	
R37	"	
F11	strange behaviour in calibration	
BF13	"

F14 \Rightarrow cable bw/ Burndy & Feed thru seems broken (open)
 \Rightarrow broken ~~wire~~ wire @ card connector at top flange
 \Rightarrow Fixed.

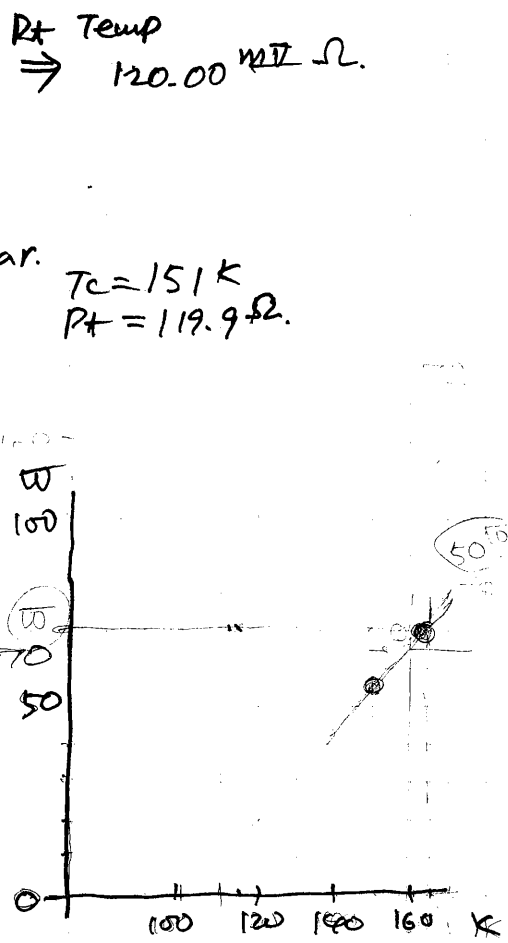
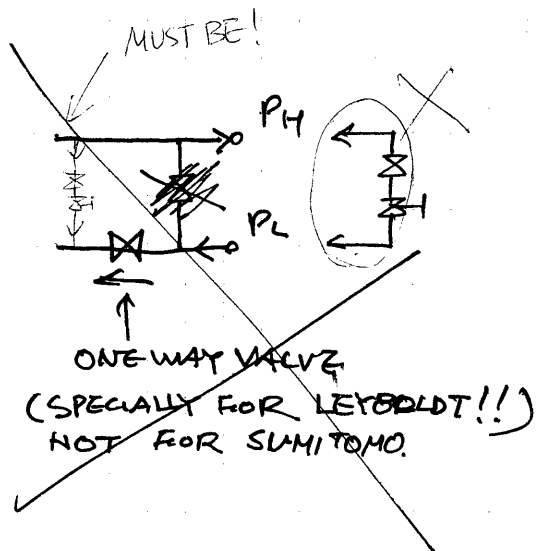
CLEARLY UNDERSTOOD:

- BYPASS OPEN ⇒ TSH2 TEMP INCREASE!!

- TOO MUCH BYPASS CAUSED LESS ΔP IN THE COMPRESSOR
 → NO SUFFICIENT OIL FLOW.
 → TEMPERATURE HIGH ALARM!

- TEST AGAIN. ~~W~~ WITHOUT BYPASS.
- COVER CLOSE.

- NEED TO KNOW THE 'RECOMMENDED' ΔP BY LEIBOLDT.

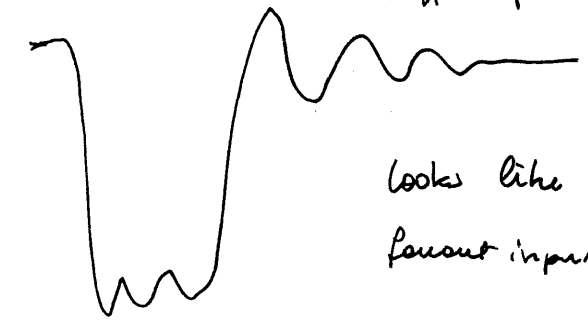
looks like this in both output & front input.

~~T11~~ Ringing

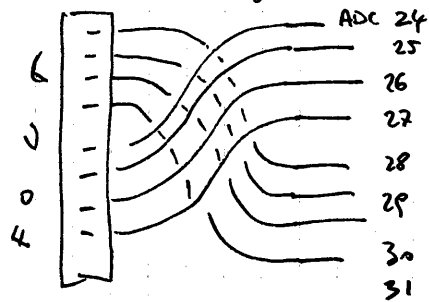
Problem of ADC 24-27 was the burst guard in FANOUT and it is fixed!

to investigate the bad behavior of ch. 24-27.

IF BAD ARE 28 29 30 31 ⇒ SIGNAL PROBLEM
 " " " 24 25 26 27 ⇒ BURNDY-BURST-ADC Problem

changed replaced burst guard in FANOUT for ADC 24-27.
