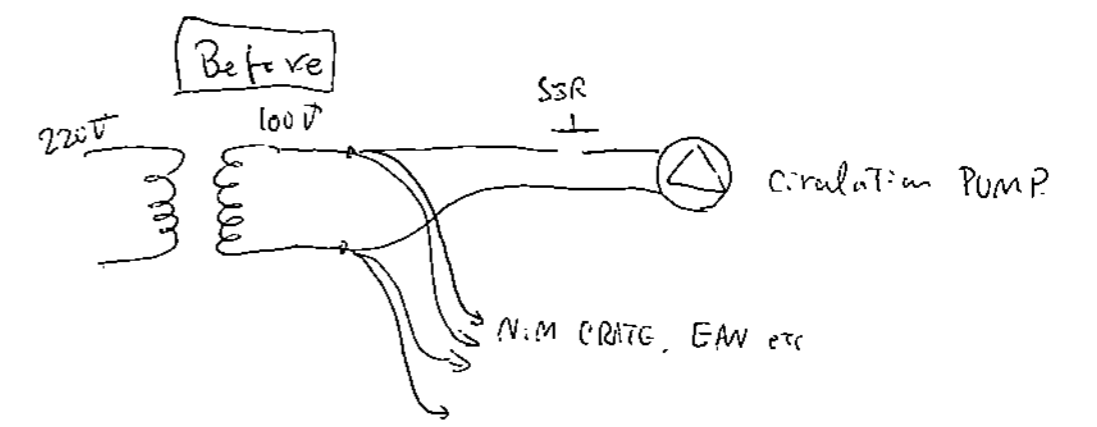
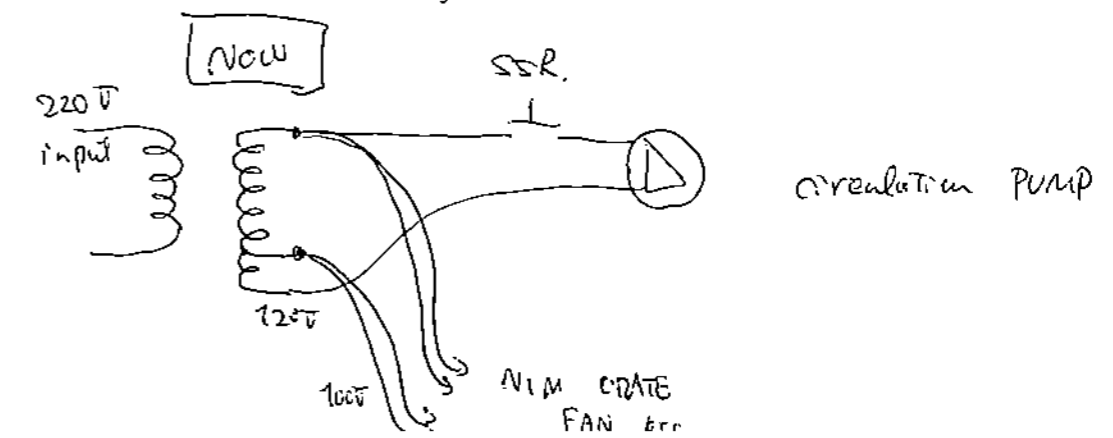
It was found that circulation pump failure in this morning was not due to ~~power~~ heat-up but to input voltage shortage (probably). When we connected the pump to 120V output of the transformer it started to work. Power cable connection is modified to supply >100V to the pump as shown below

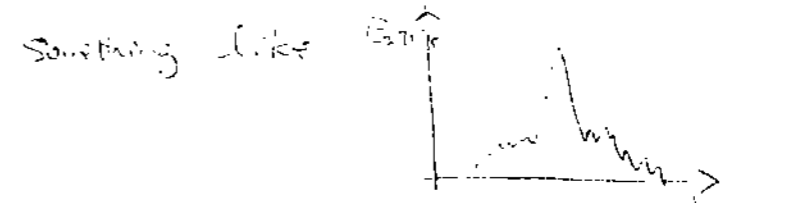
Ch 104, 272-277 have non-gaussian perseid distributions

Perseid RMS less than 5.0 may be terrible

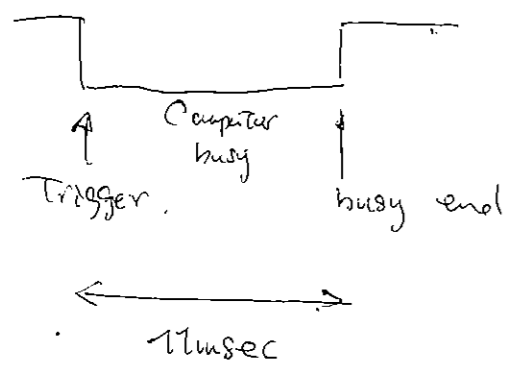
The period of "computer busy" is about 11µsec for reading all ADC-TACS. Due to this, even if one try to take pedestal/LED

data with 100 Hz trigger, we can only take at 50 Hz

• In LED runs, ROME can analyze only half of events at 50 Hz DAQ speed. As far as we monitor CPU usage on megonln02, it is used only less than 5%. So this ~~problem~~ is maybe due to communication between megonln01 and megonln02.

1. ~~use~~ modify the frontend code in such a way that we do not take TDC data in pedestal/LED runs
2. Move "analyzer (LFramework)" from ~~me~~ megonln02 to megonln01.

→ Now we can take pedestal/LED data at 100 Hz & analysis efficiency of ROME is about 98%.

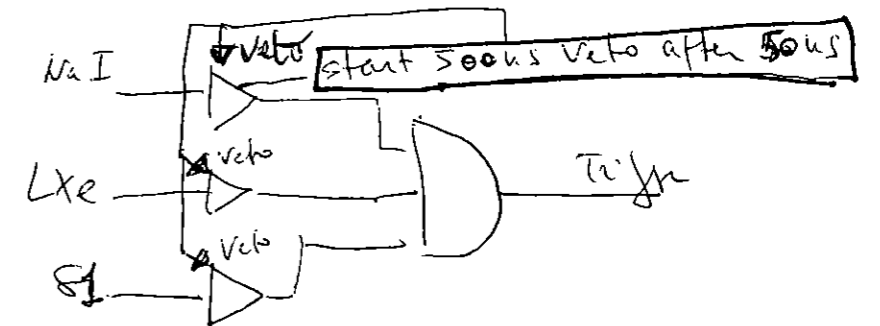
The NaI pulse is very large and make the disc. restart  $\Rightarrow$  fake NaI pulses start the coincidence  $\Rightarrow$  modified NaI discrimination: added veto

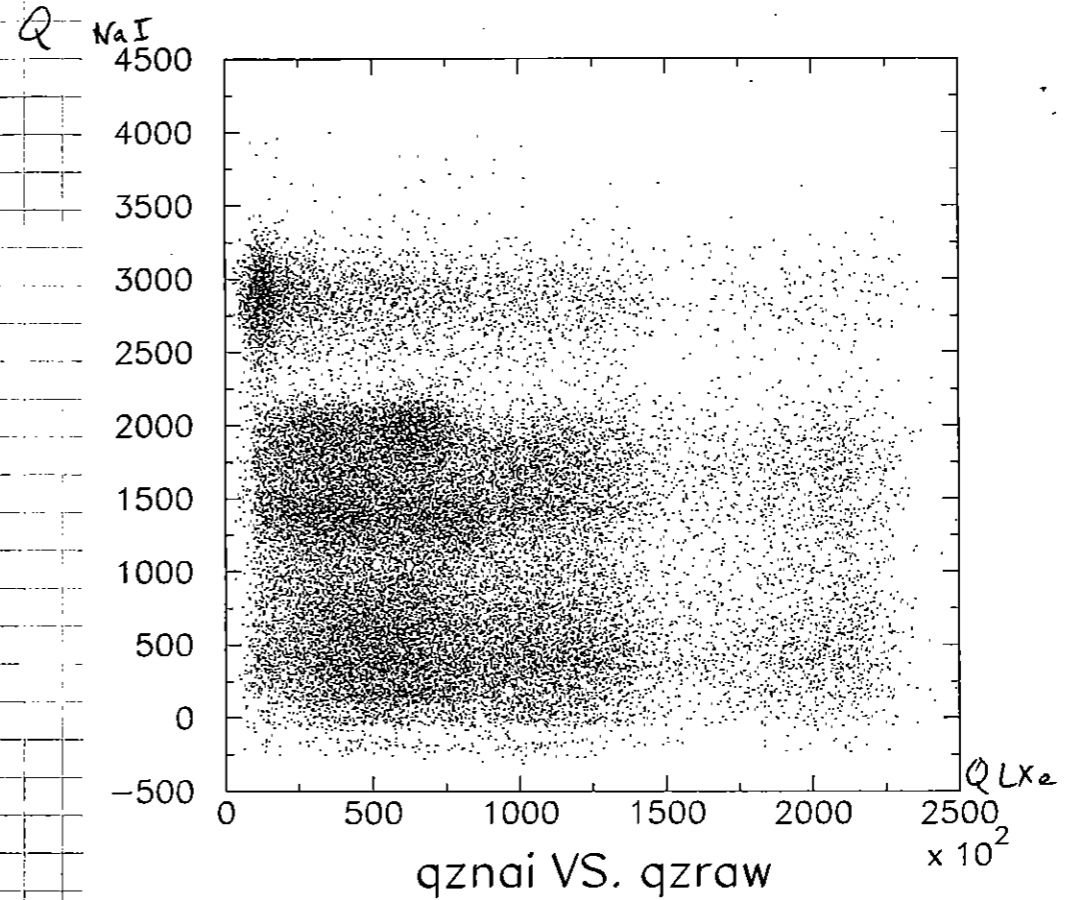
Run # 7895

The two  $\gamma$  (54, 83) peaks are not evident in LXe ???

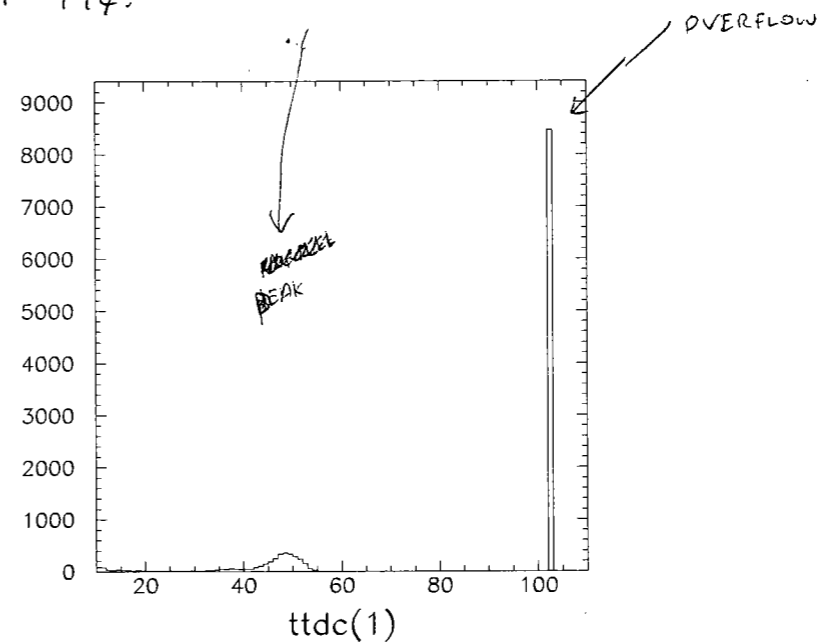
SOME STRANGE BEHAVIOR OF TIMING: i.e. let's look at the  
 PRT F14:

Maybe the timing must be checked. <sup>Correct</sup> the signal stop comes too late  $\Rightarrow$  we must delay the start by  $\sim$  60 ns

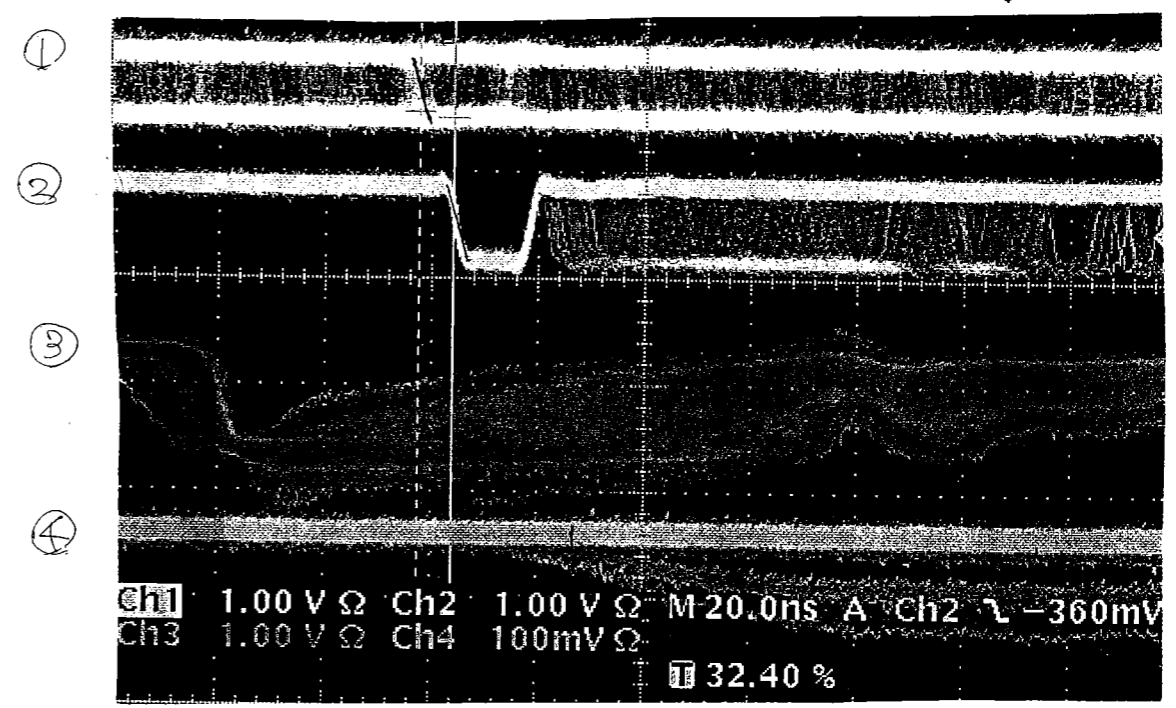
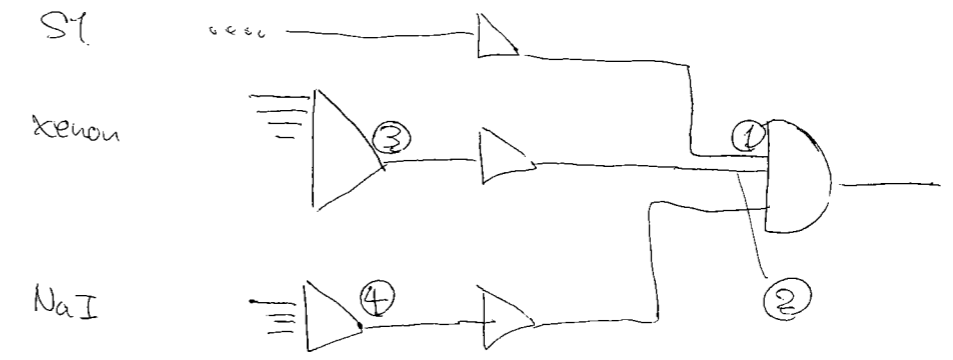
- ① S1 input signal at the coincidence
- ② Xenon input signal at the coincidence
- ③ Xenon FAN-IN/FAN-OUT output
- ④ NaI

It is found that S1 arrived earlier than Xenon  
 ⇒ Timing was not determined by S1  
 and that Xenon and NaI timing difference is about 70 nsec, which is larger than inserted delay of 32 nsec  
 Why is NaI so slow???
