COBRA STATUS W. Ootani

Feb. 15th, 2006 MEG Review Meeting

Power Supply Trouble

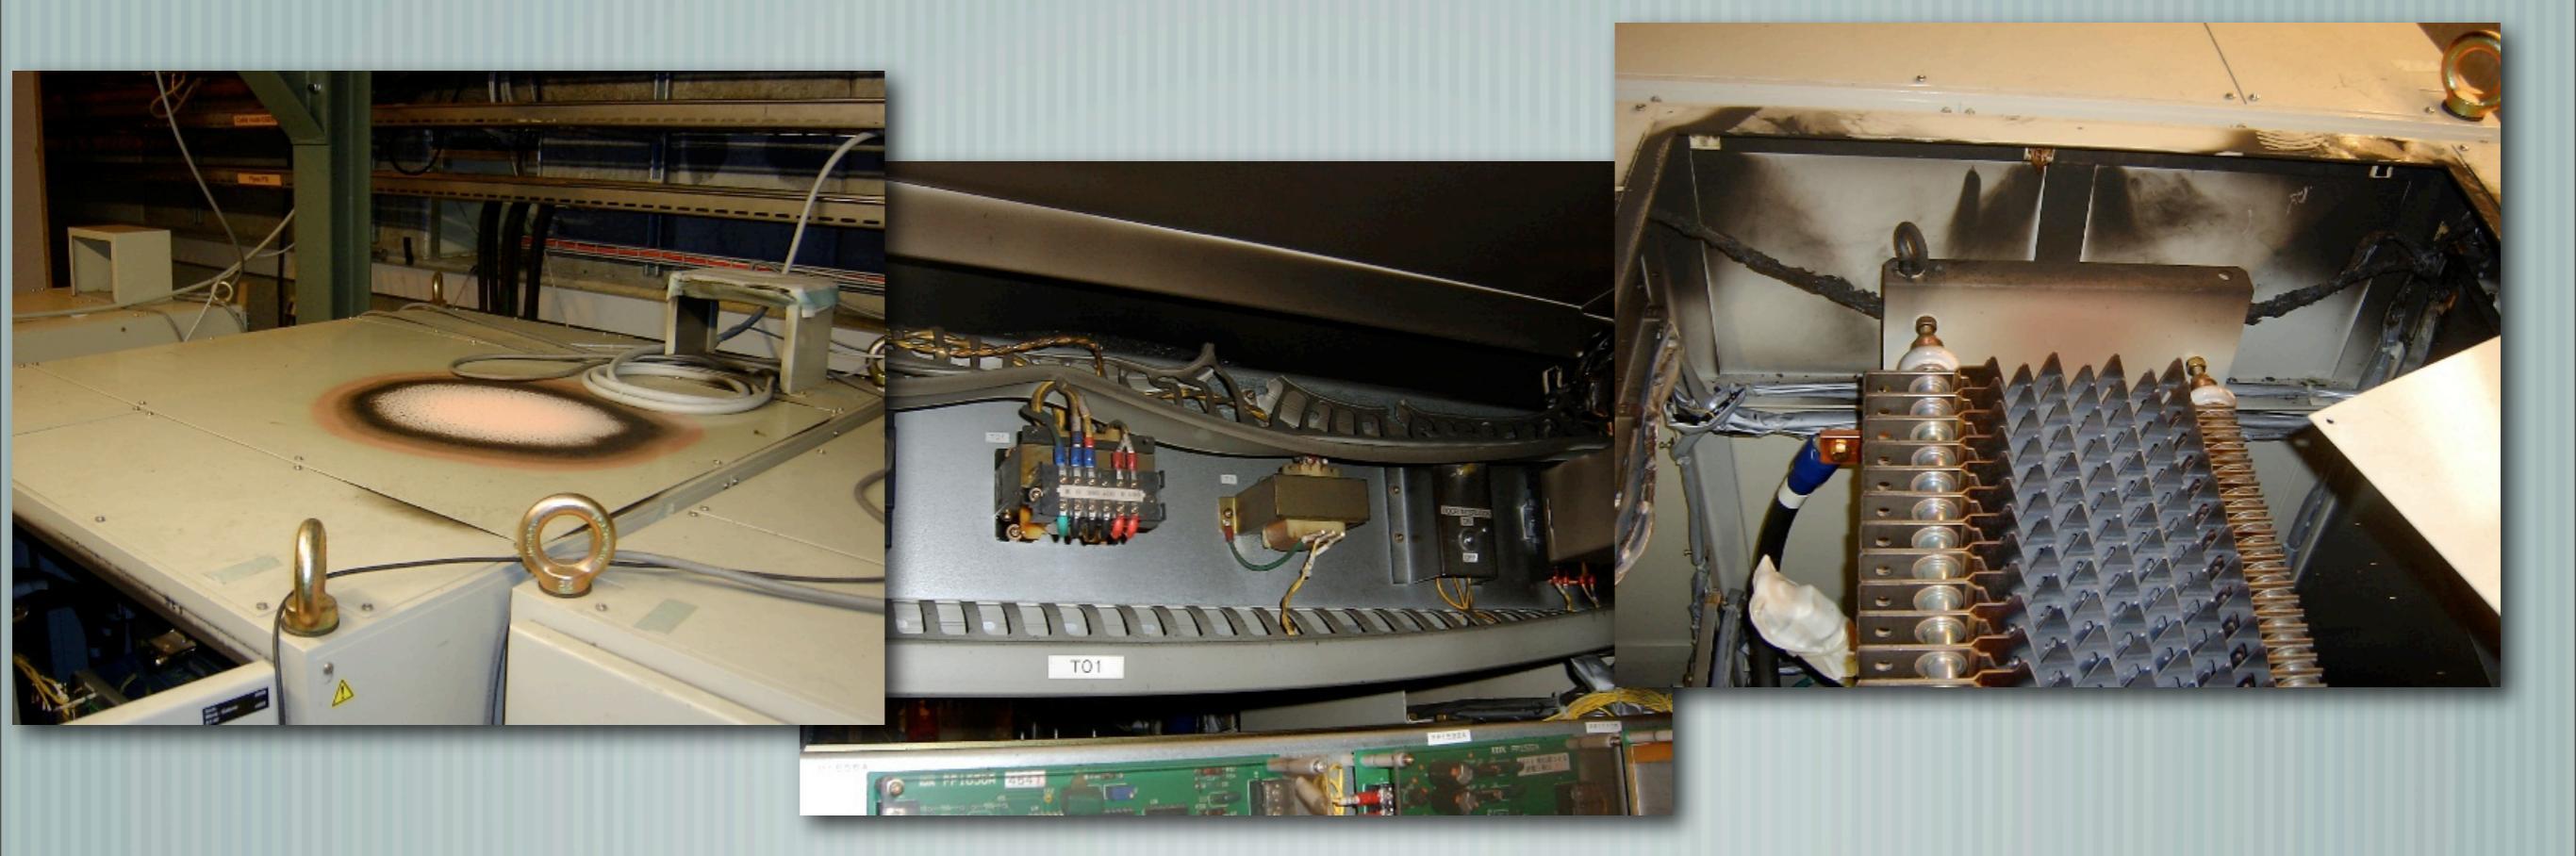
Power supply for the compensation coils was burned. Fire brigade and (even) police came to the area. Relatively big incident. Any interlock protection system in the power supply didn't work. It was really good that I was working around there.

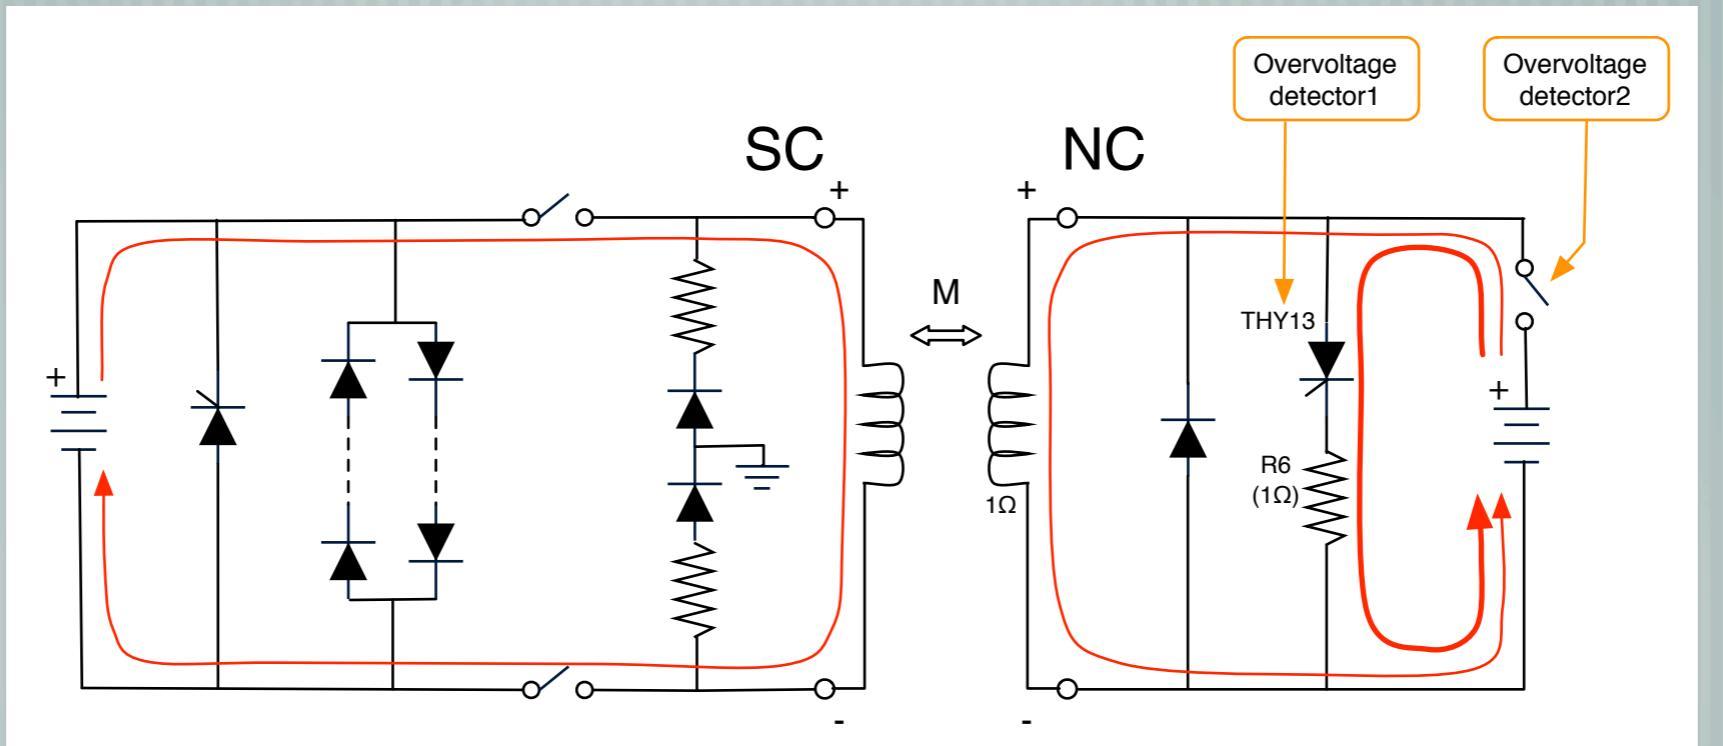
What was the failure?

Over-voltage detector is triggered (probably by external noise) and opened thyristor TH13. A big current (320A) flowed through the protection resistor R6. Generated heat: 100kW!

Crucial interlock protections were missing.

- ─ TH13 open → shutdown
 - Temperature sensor on R6

- Remove R6+THY13 because they're not necessary in our case.
 - The company misunderstood the polarity of the over-voltage caused by the SC quench...
- Add thermal sensors to all the power supplies.
- Smoke detector?
- No problem in the SC power supply.
- This problem might explain the frequent quenches in the last beam time.

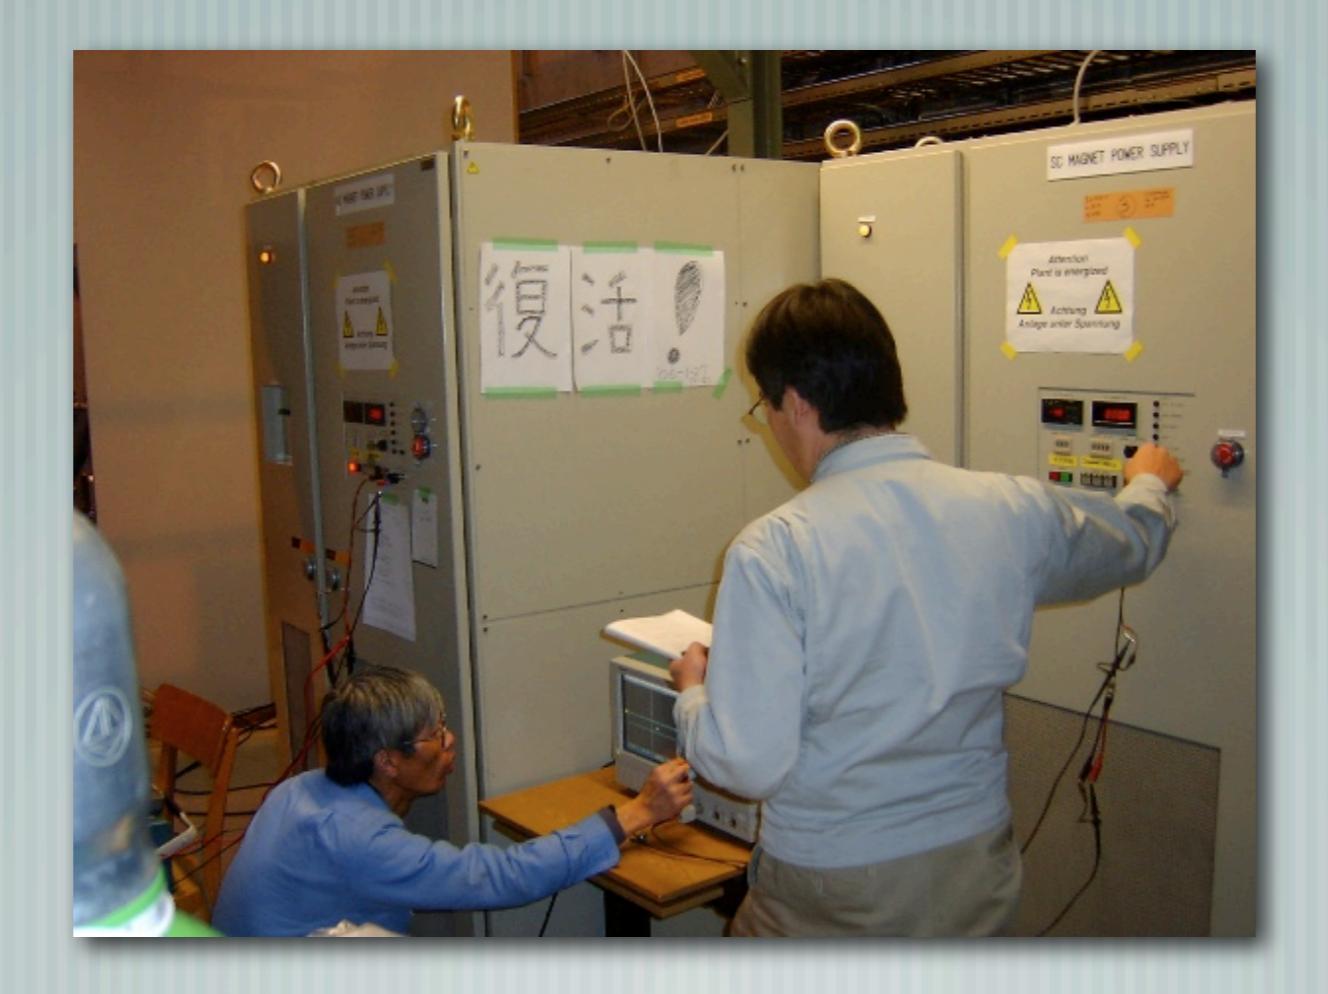
The power supply is already starting to work only one week after the problem happened thanks to an excellent work of two engineers from the company.

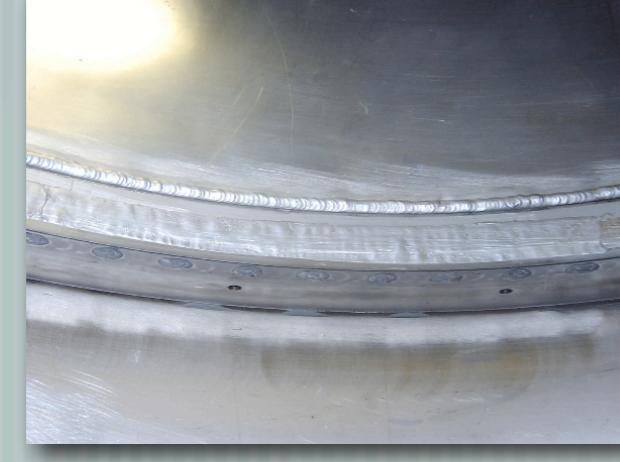
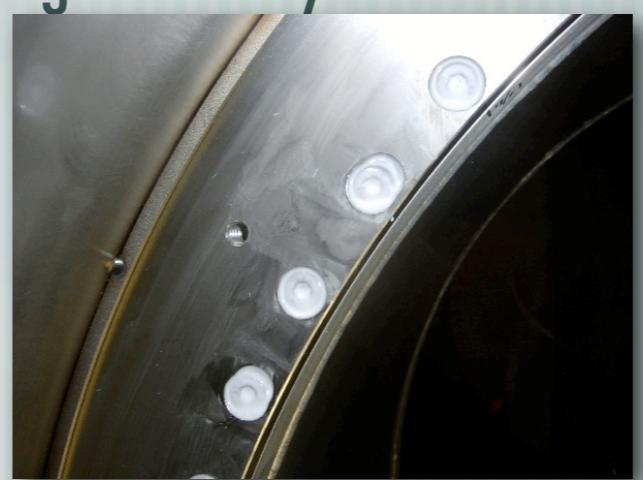
- **COBRA** cryostat was not He-tight because of the Viton O-ring.
 - Calculated partial pressure rise after one year operation: 40Pa
 - Deterioration of the thermal and electrical insulation of the vacuum.
- Fill up the gap and the screw hole with RTV elastic adhesive (Threebond 1530).
- The inside of the COBRA is filled with He-gas for the first time last December.
- Pressure rise after two weeks: 1x10⁻³Pa
- Much smaller than expected without the Threebond, but there's still leak.
- We are thinking of permanent pumping for safety.

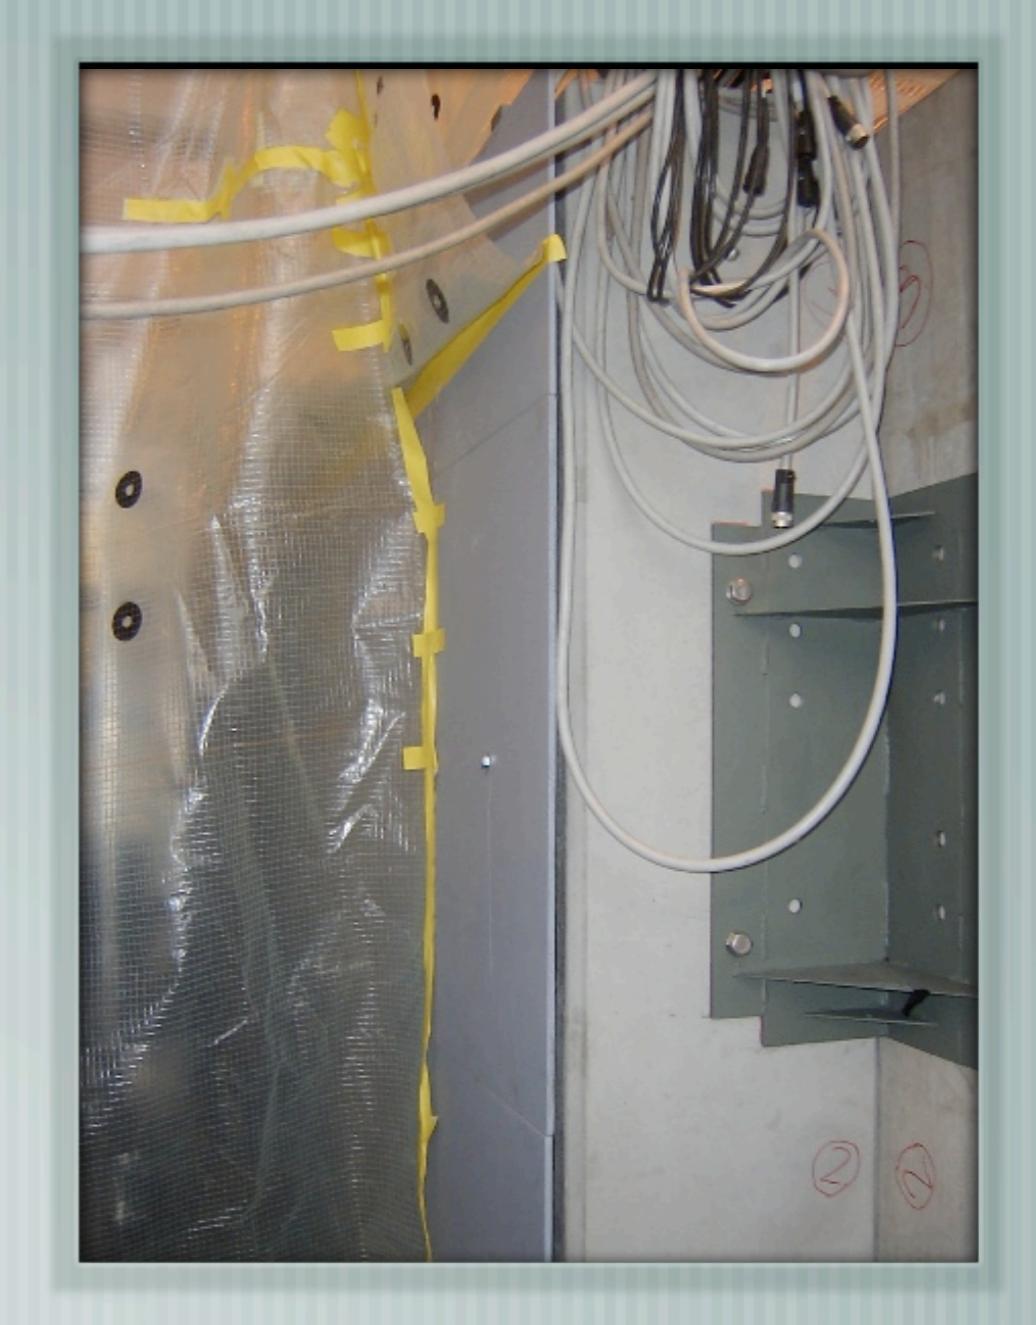
- The side wall and the floor in the E3 are tiled with 10mm-thick soft iron plates.
- The shield plates are mobile.
- It worked as expected.
 - The residual field around the detector was measured to be 2Gauss with the shieldings. (cf. 4-5Gauss without the shieldings)
- Stray field problem is fixed, finally.
