MEG実験2009：陽電子スペクトロメータの改良

西口 創 (KEK素核研), 他 MEG コラボレーション

JPS Meeting, 20-23/Mar./2010, Okayama University

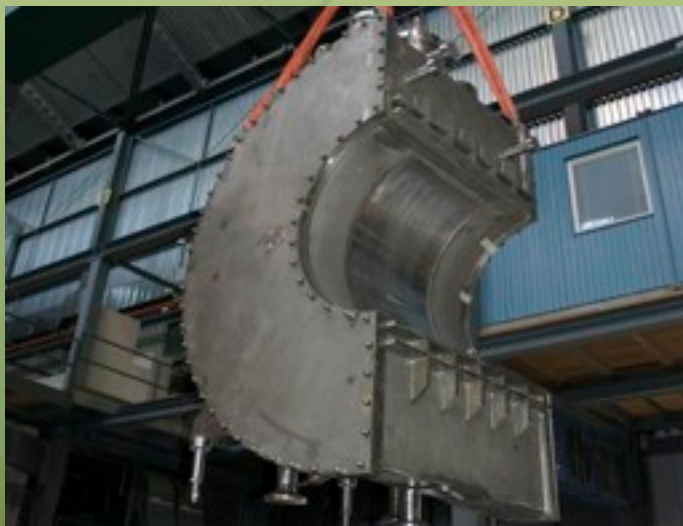
Liquid Xenon
Scintillation Detector
(gamma)

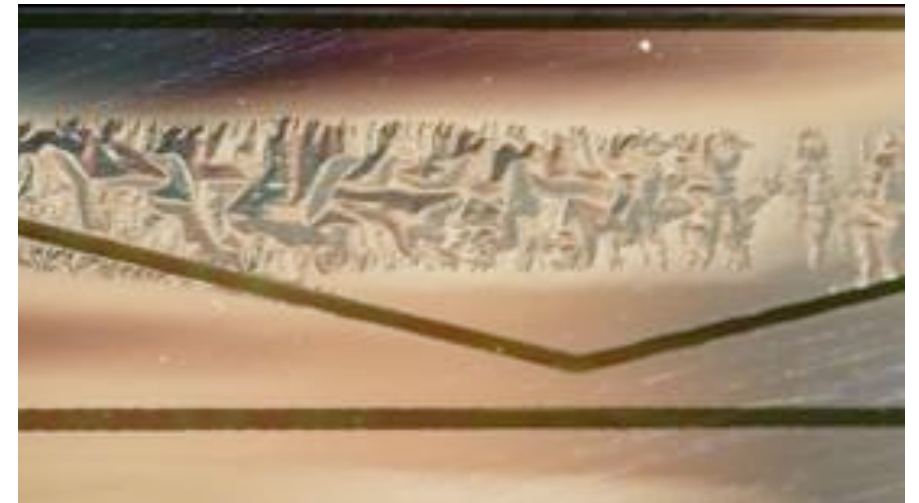
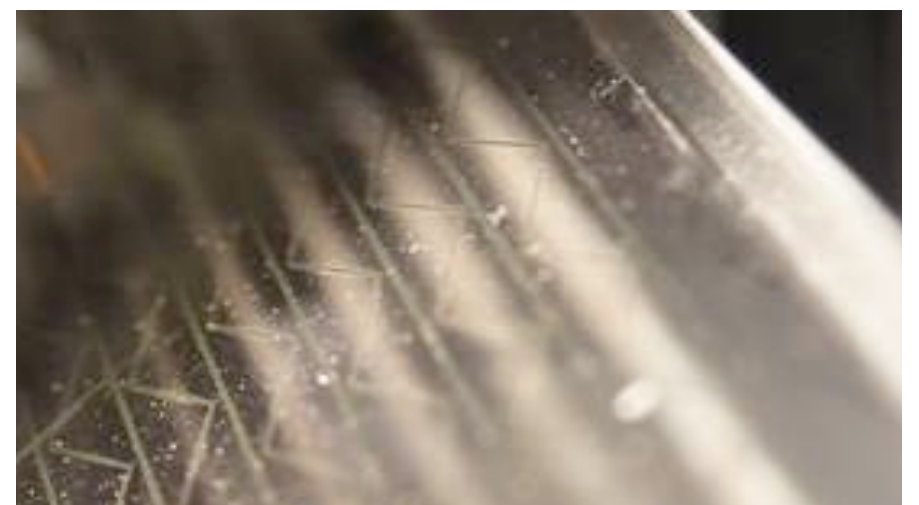
Damaged Cathode Foil

- ❖ Several “Damage” of cathode foil were observed during disassembly.
 - ❖ aging ?
- ❖ Special Vernier pattern by “ $t_{250\text{nm}}$ Al with $100\text{ }\mu\text{m}$ accuracy pattern over 1m length”
- ❖ Peeling off, Micro-holes(?), Isolating layer.
- ❖ “Source” is still unclear, but this must be solved ASAP.
- ❖ Just a quick solution; New Vernier foil with Better Adhesion by adding $t_{0.5\text{nm}}$ Ni-Cr sub-layer.
- ❖ 3 modules with new foil are getting ready, and will replace the current module.
