$\mu^+ \rightarrow e^+\gamma$ 探索実験 MEG II

2018年度の展望

- Y. Uchiyama (The University of Tokyo)
for the MEG II collaboration
- 日本物理学会第73回年次大会
(22 Mar, 2018)

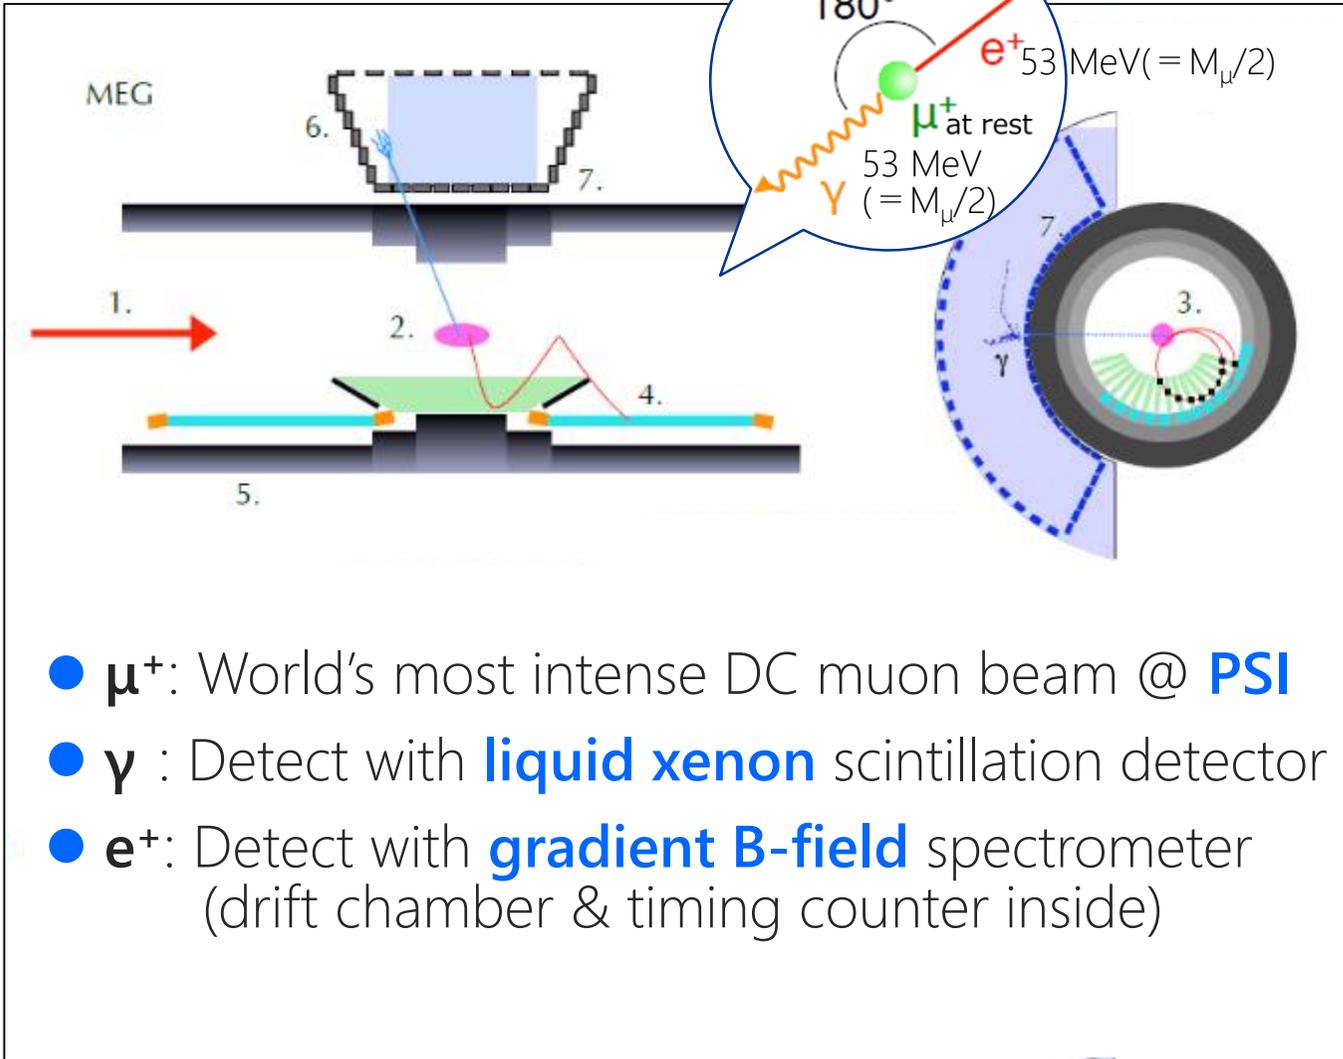
MEG experiment

- μ^+ : World's most intense DC muon beam @ **PSI**
- γ : Detect with **liquid xenon** scintillation detector
- e^+ : Detect with **gradient B-field** spectrometer (drift chamber & timing counter inside)

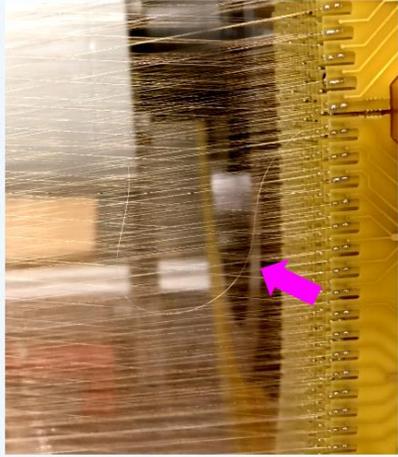
Broken Wires

- We observed broken wires.
 - Removing test
 - Under investigation
- Wiring is suspended.

Anodes: gold plated tungsten wires (20 μm)
 Cathode: silver plated aluminum wires (40 μm)
 Guard: silver plated aluminum wires (50 μm)

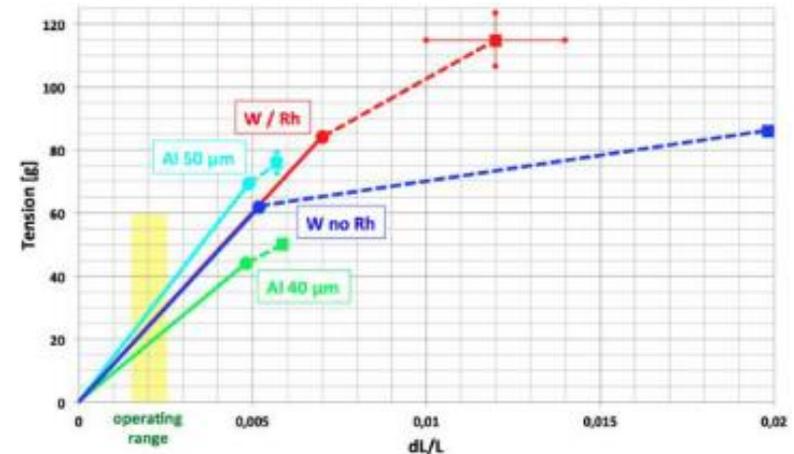
Fundamental information

- Total 13,056 (sense wire 1,920) wires
- **Ag plated Al field wire**, 40 or 50 μm
- Nominal stretch **+4 mm** (40% of elastic limit)
- Acceptance test: $10 \times$ **+5mm** stretch

6 wires broken	out of 4540	+4 mm	in 10 months
8 wires broken	out of ~150	+5 mm	in a week

- ❑ All Al wires, no W wire.
- ❑ Evidence of acceleration by tension.

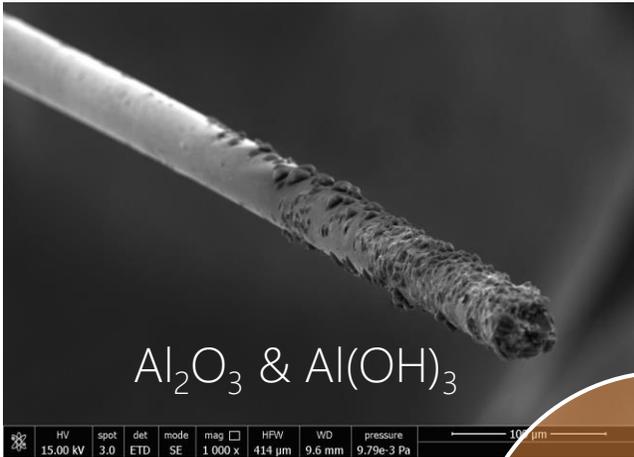
Corrosion (腐食)

Detailed investigation...

"Reliability study of wire bonds to silver plated surface" IEEE Trans. Parts Hybrids Packaging PHP-13(1977)419

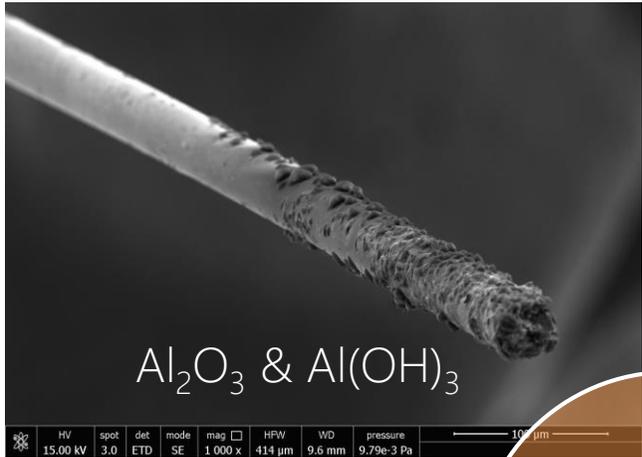
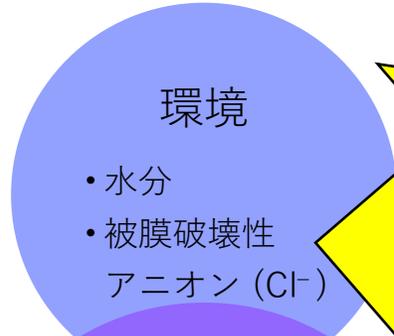
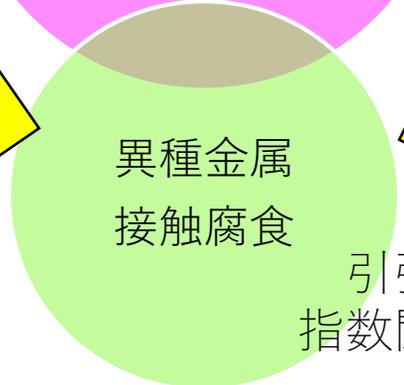
Corrosion (腐食)

湿度を下げる、
チャンバーを封じる

引張力を下げる

上質なコーティング
or
コーティングなし

腐食に弱いアルミワイヤーにこだわる??

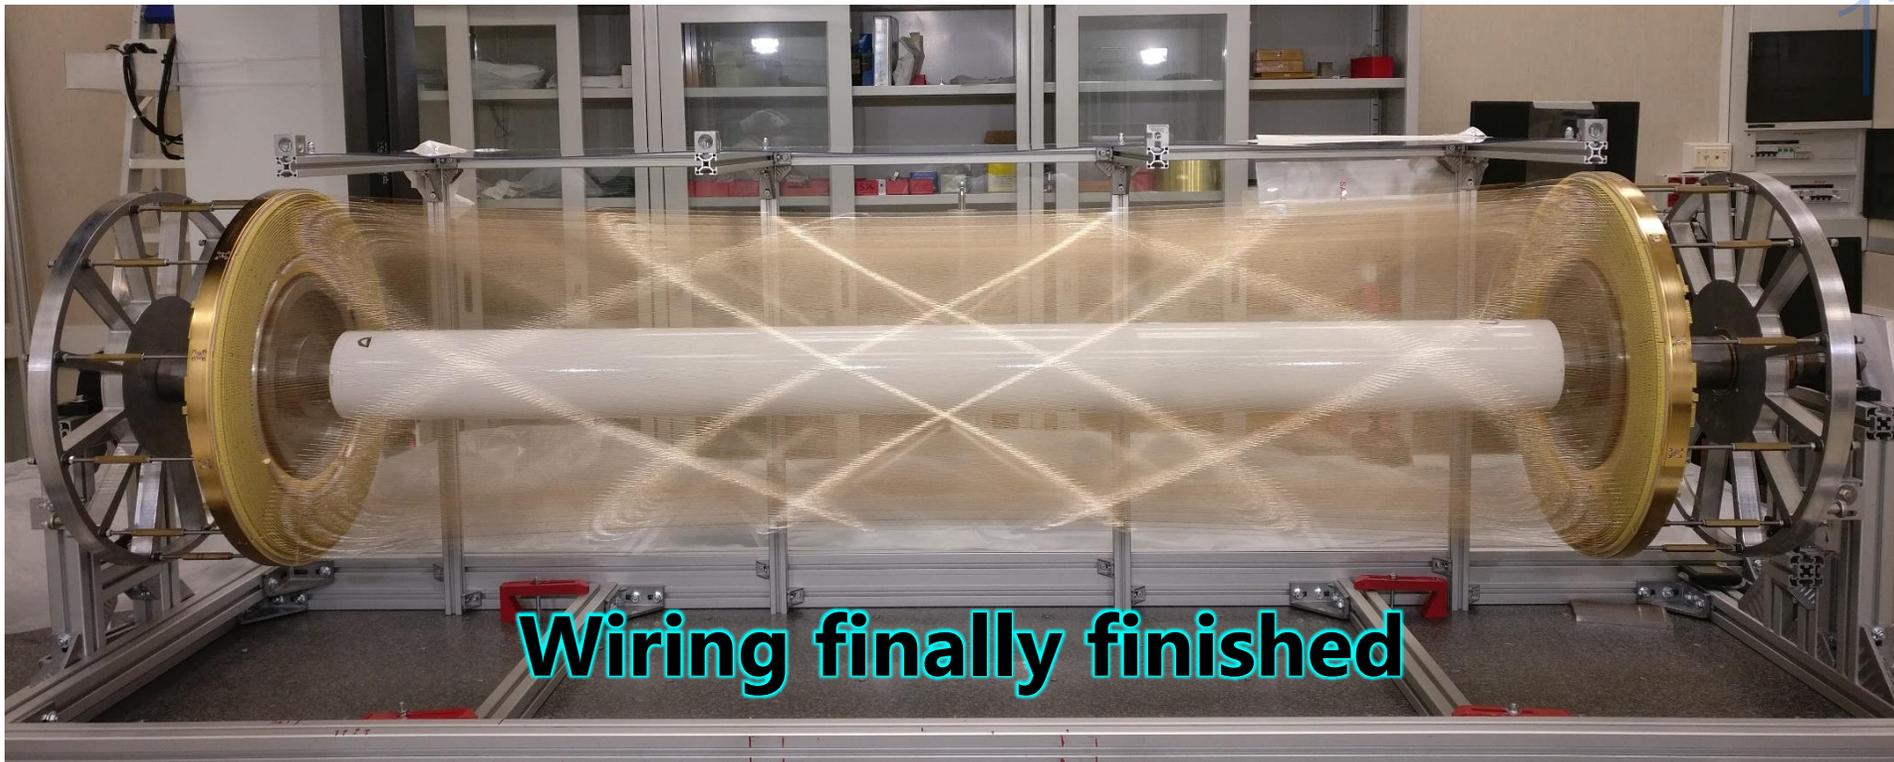
1. More strict humidity control: <20% locally
2. Reduce elongation to +3 or +3.5 mm
 - Since Aug, **no break** has happened.
 - Resumed assembly (27th Sep) to complete the chamber, but
 - reduce # of layers: 10 → **9** layers
 - ▣ Reduced efficiency by 10%
 - Use & operate it this year
 - ▣ Now closing chamber (humidity → 0%)
 - ▣ Bring it to PSI in May by truck
 - ▣ then install in Jul
 - ▣ Commissioning → engineering run
 - Only the way to go; be aware of hidden/unexpected further problems

Wiring finally finished

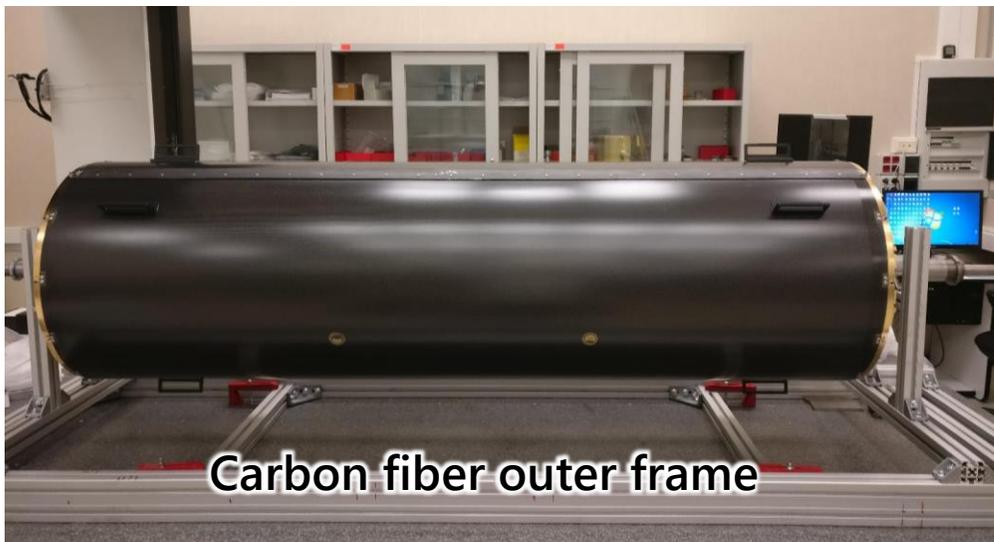
Carbon fiber outer frame

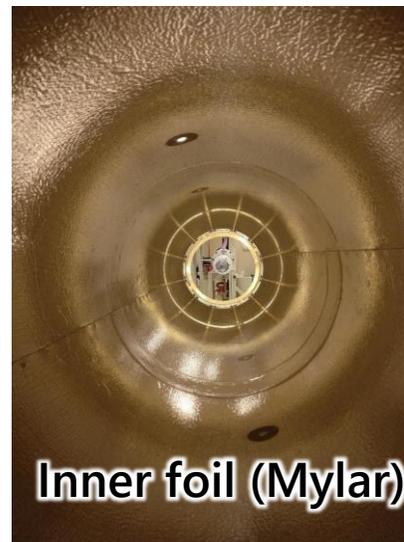
Inner foil (Mylar)

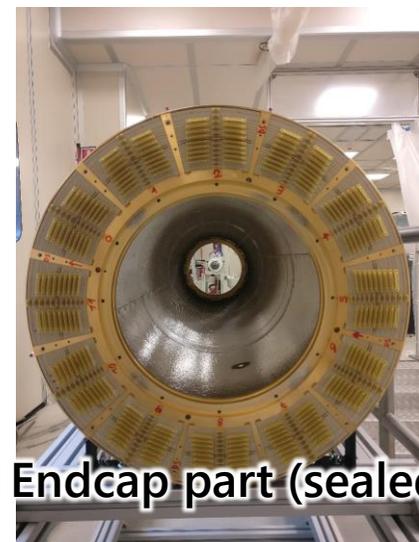
Endcap part (sealed)

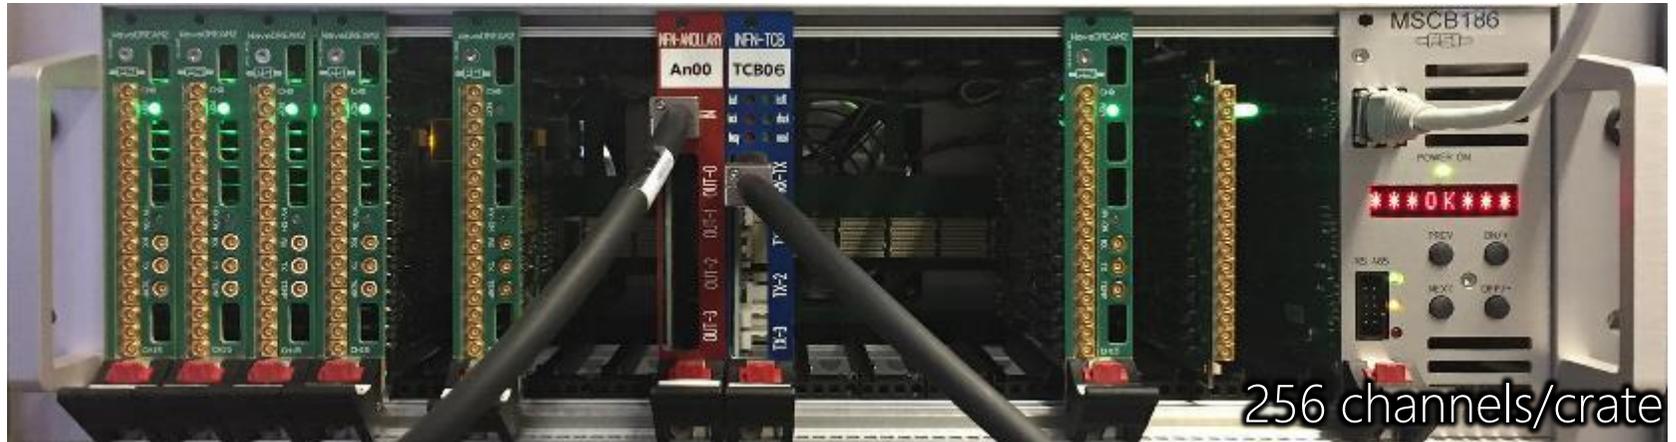
- New DAQ/Trigger system

- ▣ Use it for all MEG-II detectors in common
 - ▣ Dense & compact system to cope with increased # of channels.
 - ▣ Custom multi-functional readout board: **WaveDREAM**

*Analog FE (programmable shaper & amplifier),
SiPM bias-voltage supply, waveform sampling (DRS4),
digitization, discriminator, FPGA-based trigger in one module*

No pre-amplifier at detector side

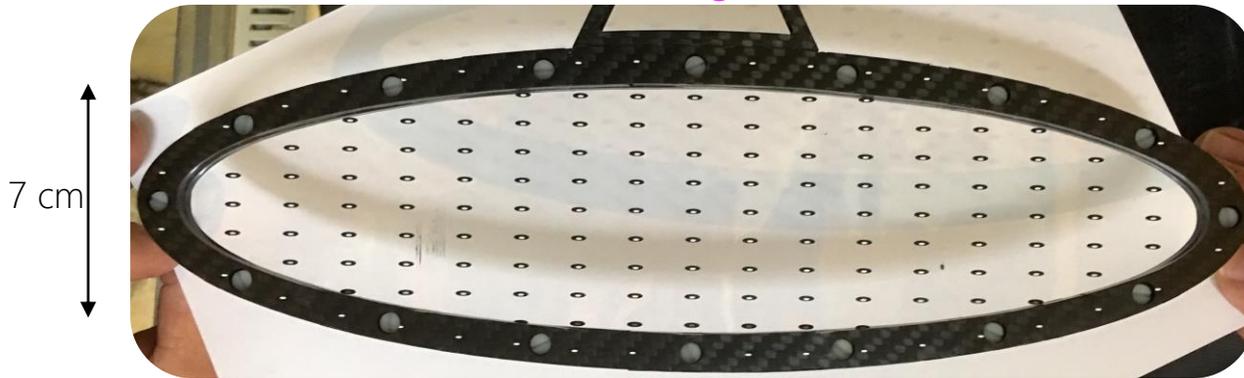
- MEG II new target system
150 μm thick scintillating sheet (BC400B)

dot-pattern printed on the sheet

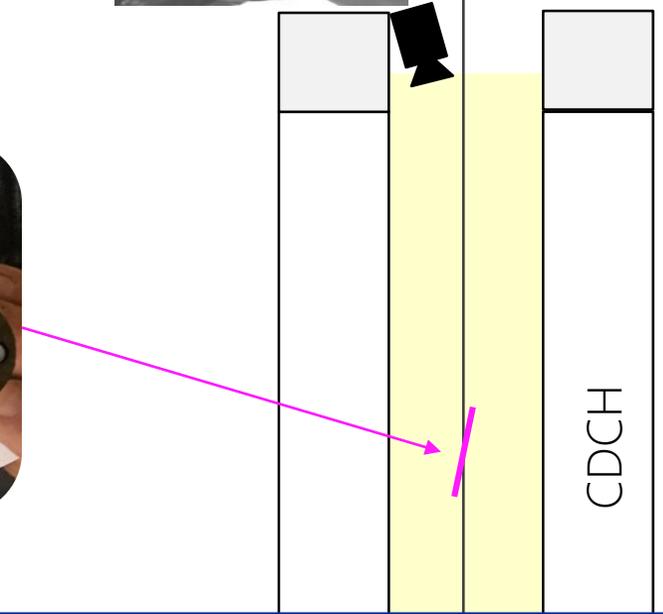
- Two **CCD cameras** view the target

- ▣ Take pictures of the dot pattern
- ▣ To reconstruct **target position and shape** in photogrammetric way
- ▣ The CCD camera didn't work well in B field \rightarrow search for alternative

- ▣ In-situ measurement of **beam profile & intensity** by detecting the scintillation light

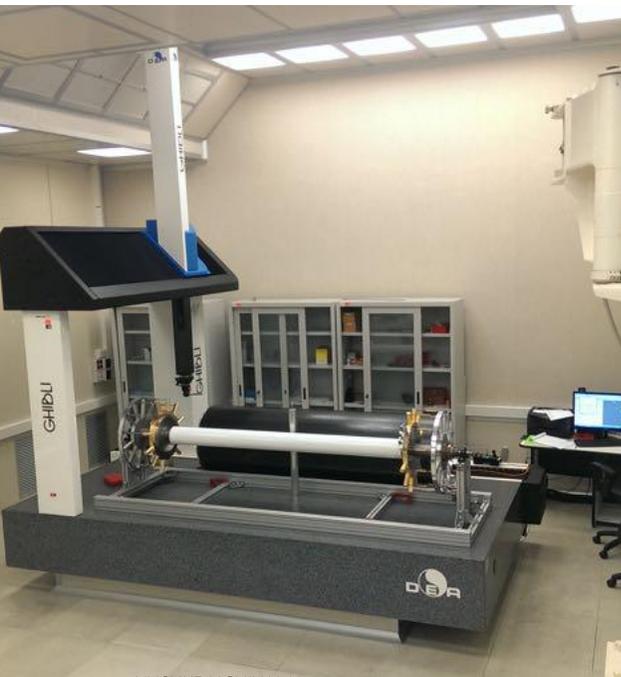
CDCH: Wires acceptance tests

- **Optical measurement** of the position of **3 reference markers** on wire-PCBs
- **Alignment and extra-elongation** tests: +1mm wrt to the nominal wire length repeated 10 times (62.5% of the elastic range)

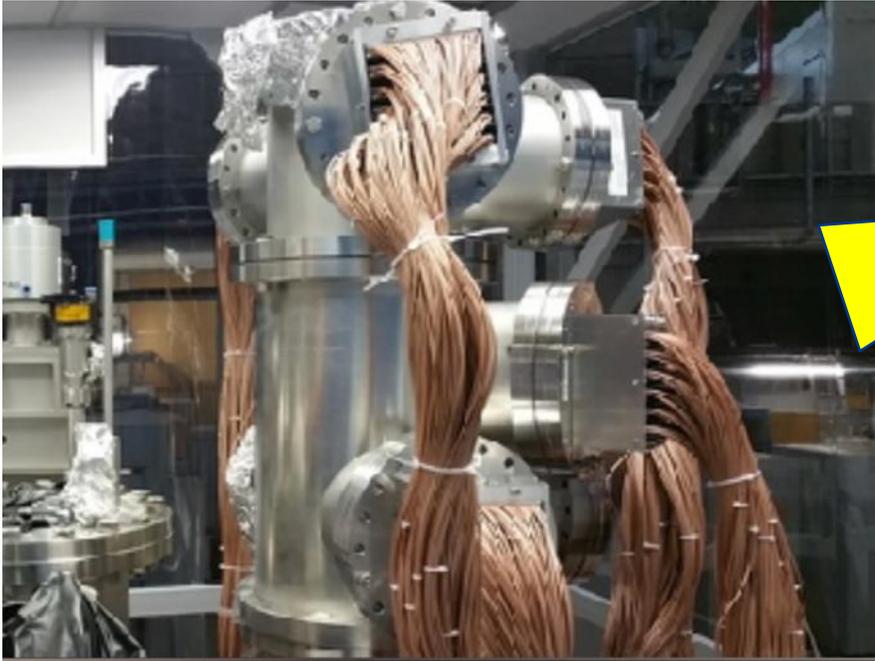
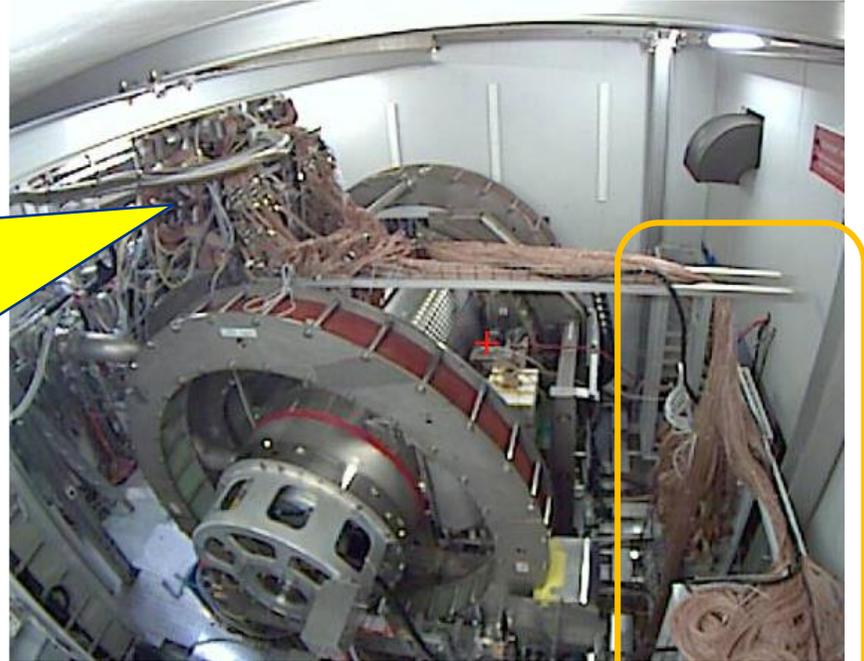
Placement of Preamps

~5000 cables

- No possibility to put preamps inside LXe (600W)
- No possibility to put preamps closer to detectors
- No guarantee that noise would get better
