Trigger Timing adjust again

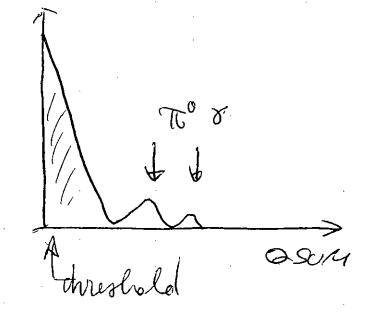
New trigger "8 clusters OR" has effectively very low threshold. The QSUM histogram in RUN 5562, 5563 is like that shown in the light.

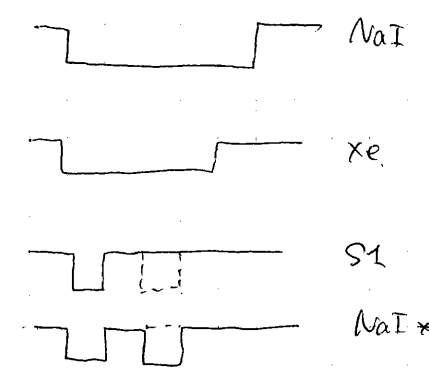
In RUN 5562, 5563, accepted event rate was ~30Hz, while from scaler data trigger rate was ~40Hz, which may indicate there is 25% dead time, even at this trigger rate. The DAQ has capability to take up to ~90Hz without dead time. So this is probably due to mistake of providing scaler signal.

If S1 signal comes again after 25 usec, the coincidence signal may be generated twice depending on the coincidence module setting. This must be checked and observed to change the way for providing signal to the scaler.

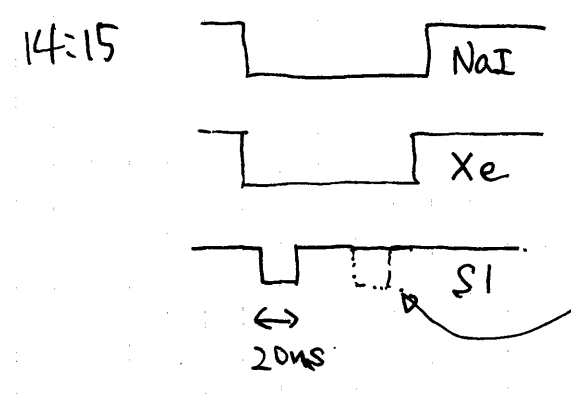
to remove these accidental coincidence, SI gate width changed to 130 ns from 20ns.
 No changes for timing.

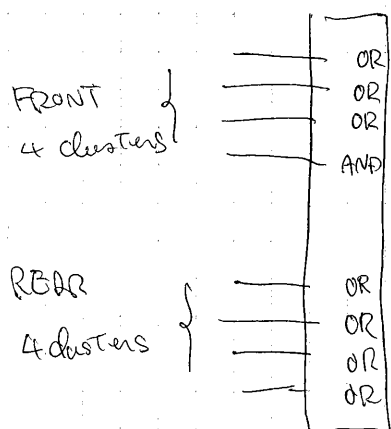
Only this channel set to be "AND"

is found in RUN 5581

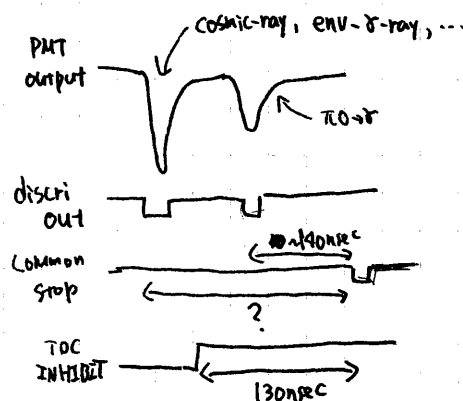
In principle it is impossible to generate ~~INHIBIT~~ till 130-nsec past of ~~COMMON-START~~. possible

Which is better, { COMMON START for every TDC which requires 45m cables, or COMMON STOP for some TDCs which requires 60nsec cables.

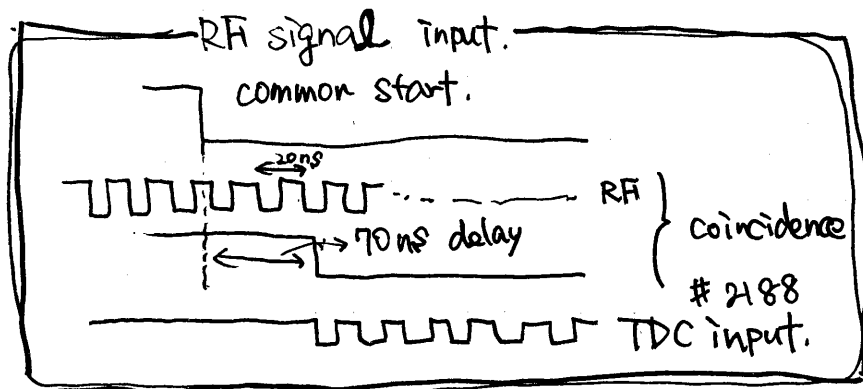
Previous TDC data was thought to be ^{for RF} deadtime. So we veto the first 70 ns RF signal and then we could see TDC data of RF. and, Logic fan-out ~~switch~~ inputs after G.F. seems to be mistake. 2 inputs from 2 different G.F.s are supplied during tx/b switch mode. → fixed.

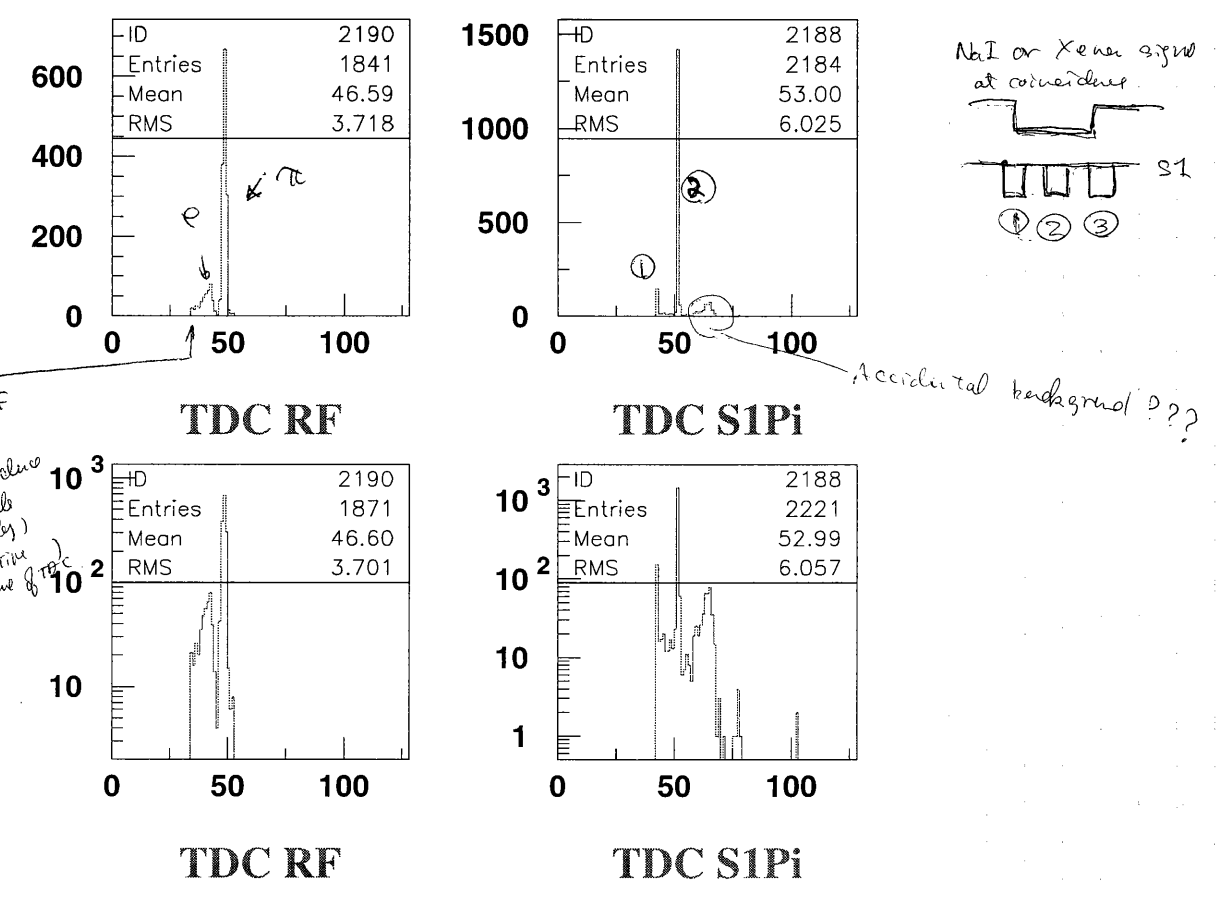
Coincidence timing of delayed start & RF
 70nsec - 15nsec (Coincidence window delay)
 - 20nsec (intrinsic time of TDC)

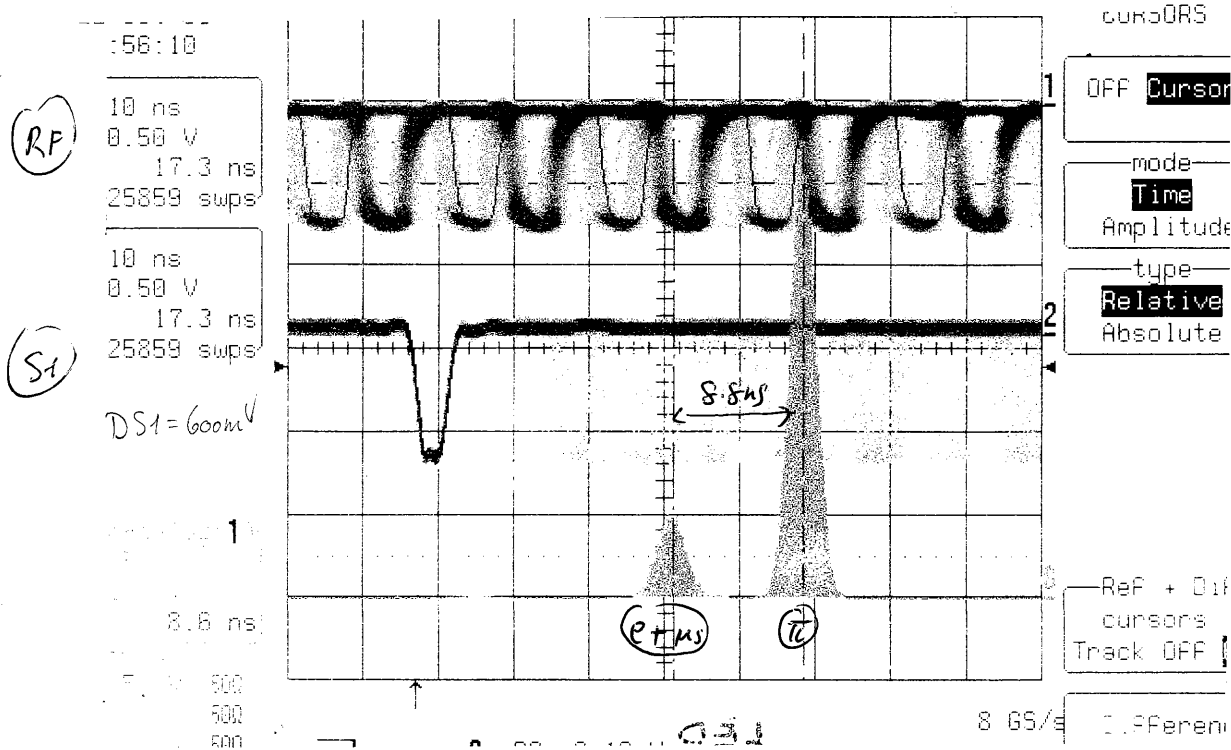
The timing for TDC RF Spectrum should be made as follows

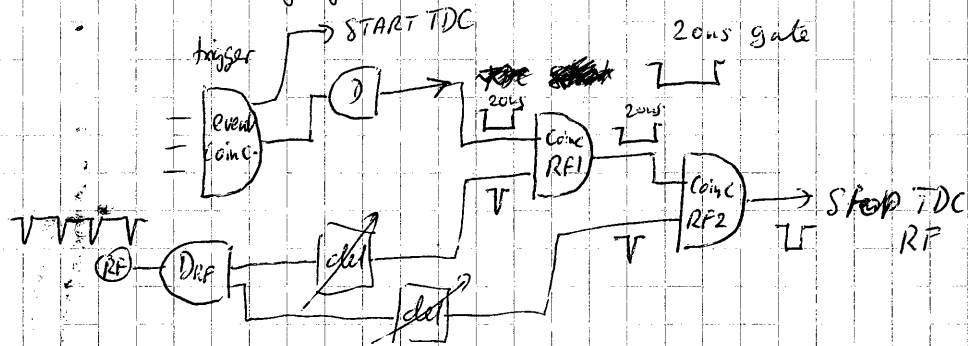
Coinc RF1 makes Coincidence between trigger (S1, ...) & RF within a 20ns wide gate $\approx 1 RF$ period

Coinc RF2 makes time timing made by RF for TDC this should

— one has to select the delay carefully such that the window of 20ns is placed to give max separation for e⁺ / e⁻

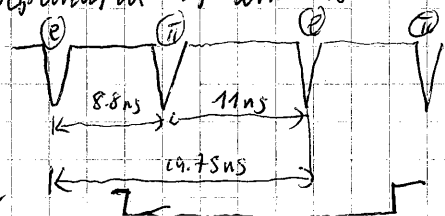
if separation as above is $\sim 9ns$

e.g. Place window here

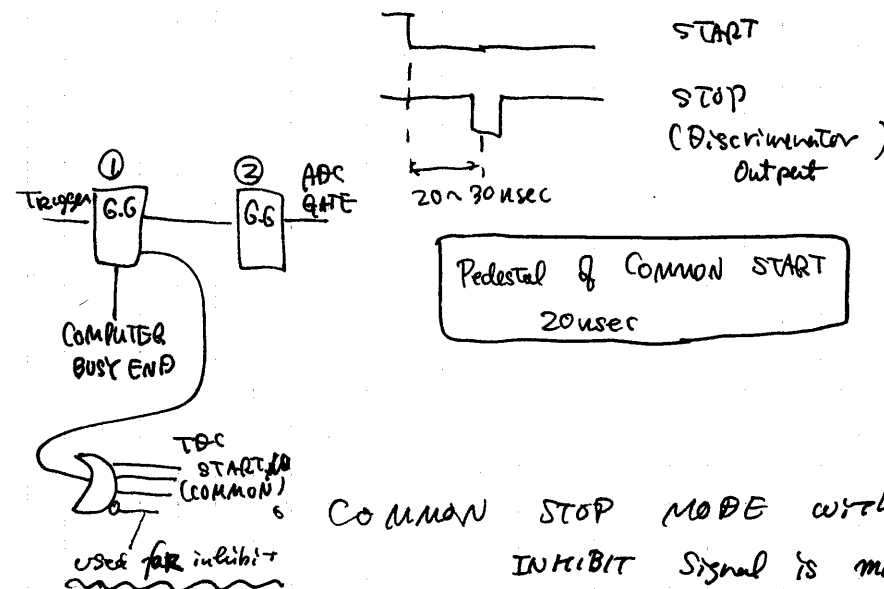
o COMMON START MODE

Because there are pedestal of 20 nsec wide, we fail to take some events in this mode.

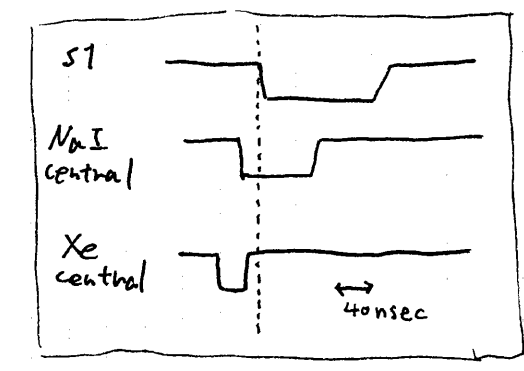
checked ~~the~~ timing at 4 fold logic unit for π^0 trigger

⇒ added discriminator for Xe central

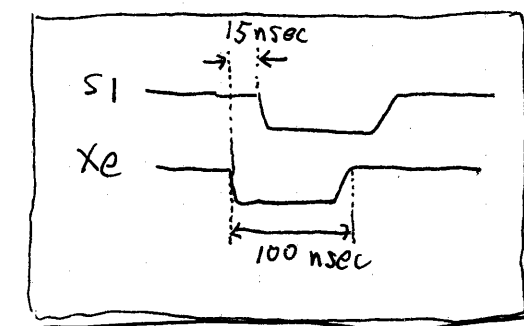
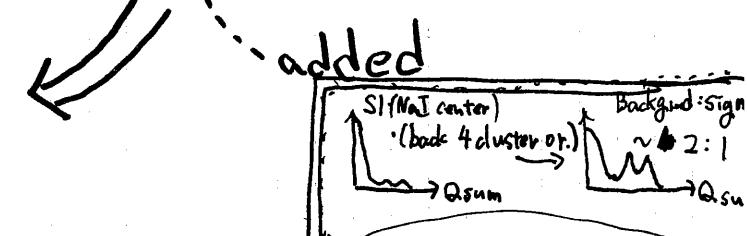
It is necessary to check if signal is also reduced or not

changed MIM Discriminator th for back clusters to -75 mV to require two PMTs for each cluster ⇒ Background events are reduced.

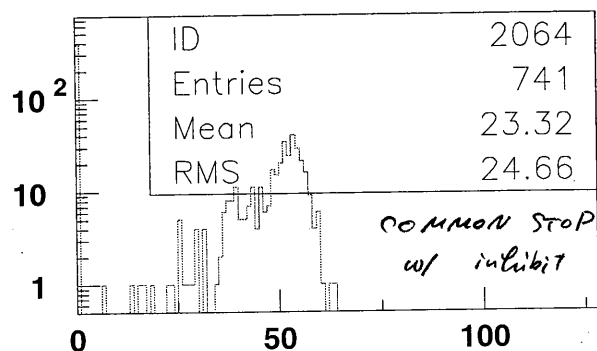
TDC T38

Signal for TDC Common Stop is delayed. (16usec)

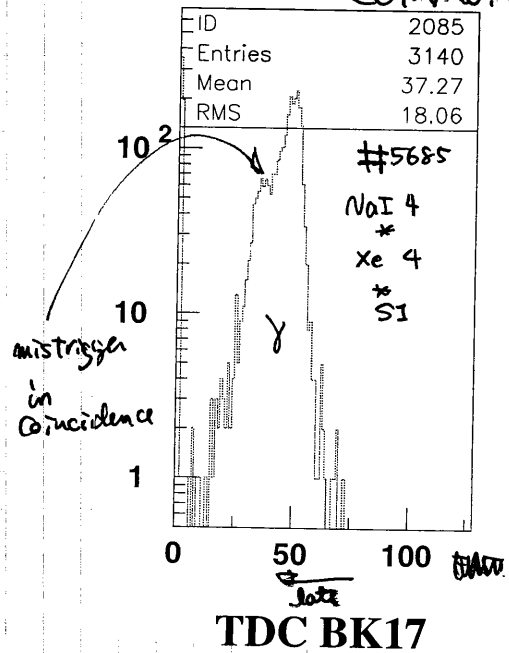
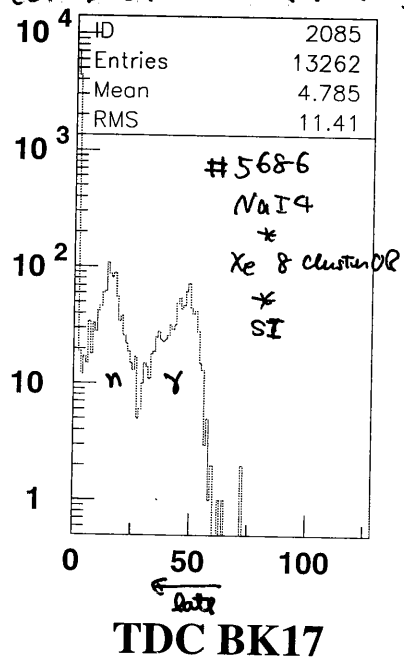
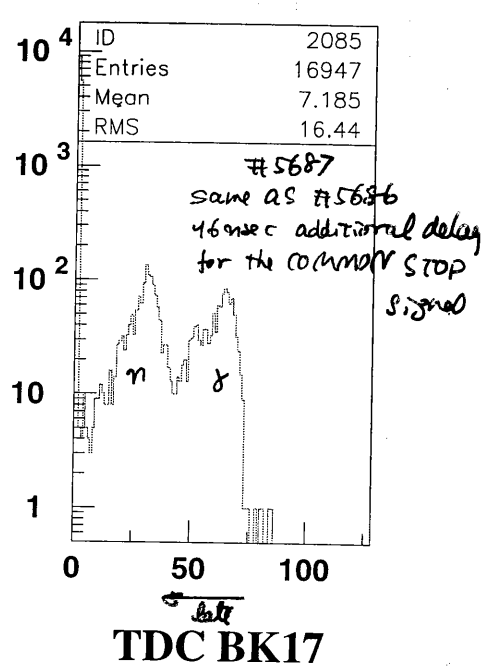
COMMON STOP MODE OPERATION

We really see neutron in LP xenon detector!

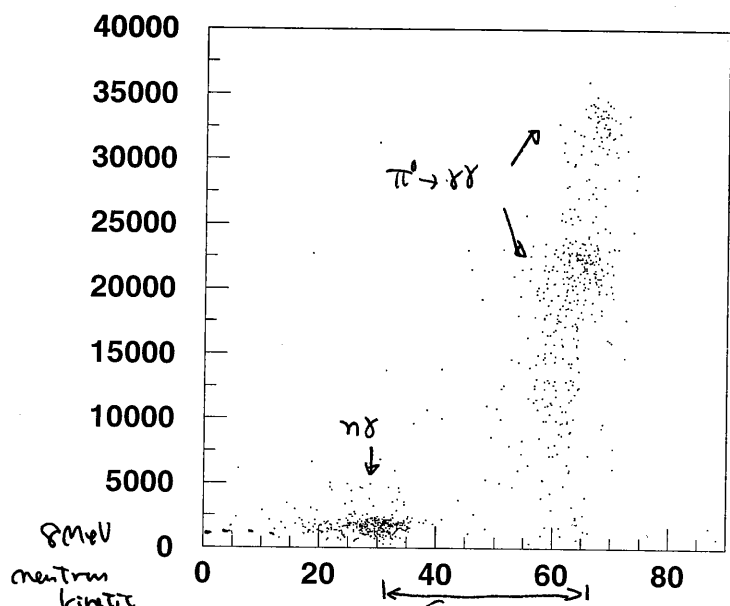
TOF difference between γ from π^0 & n from $n\gamma$ ~ 30 nsec

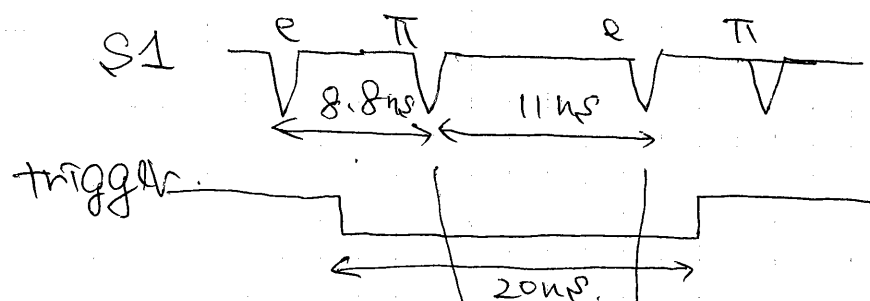
RF signal into TDC modified as Peter suggested (see this lognote of 22/oct/2003) to get better (e, μ) and π discrimination.

• diagram also shown in that Peter's log.

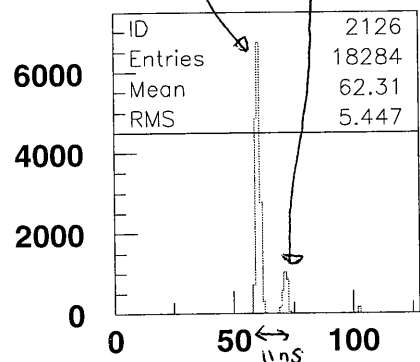
TDC RF

^{only} S1 triggering data sample

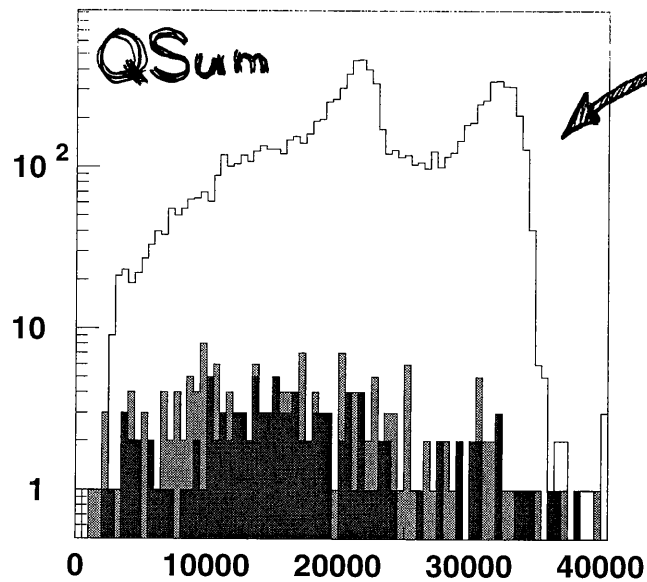
QSum spectra corresponding to 3 kind of measurements.

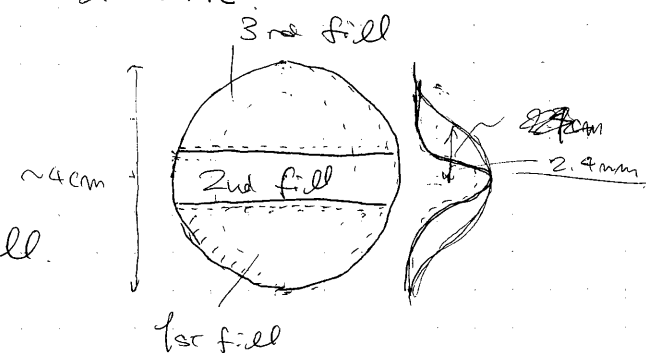
- Target seems to be filled with
liquid hydrogen as can be seen in the
increasing trigger rate while we filled the cell.

- Beam profile at the cell ~~is~~ longer compared
to measured profile (vertical) before placing
the degrader. \Rightarrow need profile measurement at the target position
with degrader.

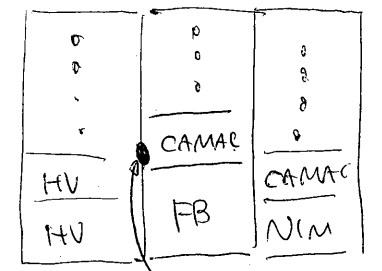
⚠ LED #7 connection polarity is opposite!
LED #1, 6 & #8 needs "inverter" for flashing with CAEN LED driver. But for flashing LED #7 we have to remove it.

↑ This opposite polarity should be fixed on Wednesday in order not to confuse shift crew.

around here inverters are held to the board with 3M band.

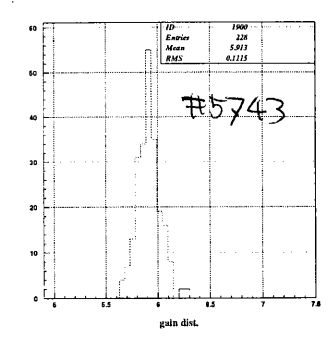
GAHN Distribution evaluated in #5743

#5730 (LED #1 & #5)
Mean 5.927
RMS 0.1129

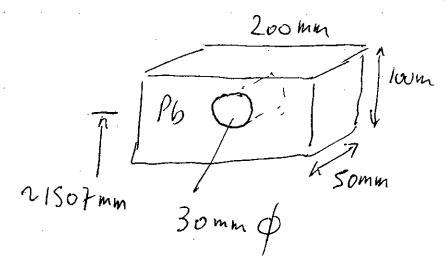
- We install

Pb collimator @ beam height IN FRONT of LP Lxe detector

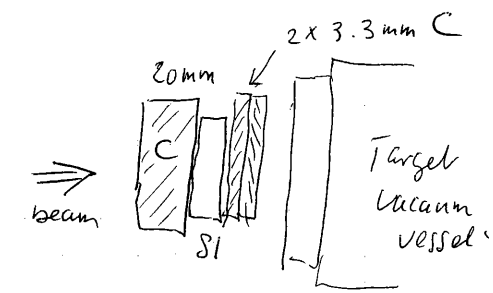
replace original Degraded:

18¹⁶ Run # 5763 π^0 -trigger with EXTRA 30mm ϕ Pb collimator in front of LP - normal degrader 20mm + 2x 3.3mm C

S_{π⁰} RF ⋅ ⋆ (NaI) normal 4598/10⁶p
 trigger rate ~ 0.57Hz with aperture ~ $\frac{\pi 3^2}{4} \sim 7\text{cm}^2$
 before had ~ 32Hz for aperture (10x10)cm² = 100cm²
 ∴ expect present rate 7% i.e. ~ 0.2Hz

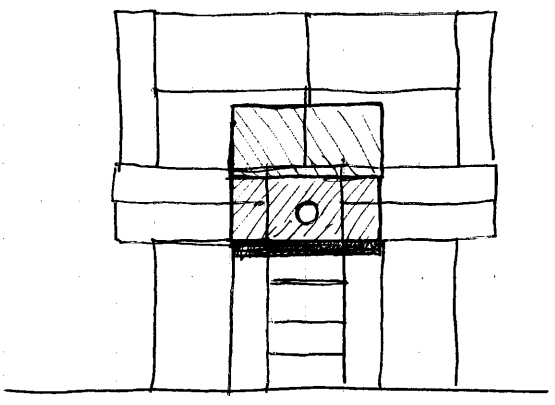
Check of the new collimator position:

Refer to 17/oct/03 for the lead wall in front to the LP

- ▨ 8mm iron spacer
- existing lead bricks
- ▤ lead brick with the 30mm hole (50mm thick along the y direction)
- ▩ further block added after run 5767 to cover

an existing aperture of 15x100 mm² (25mm thick along the y direction)

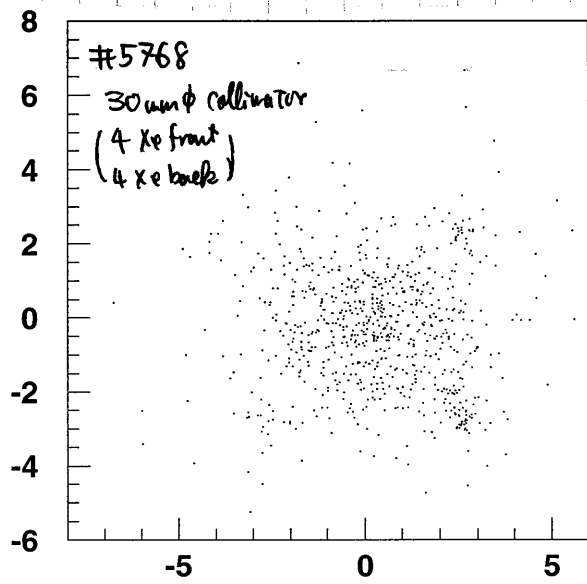
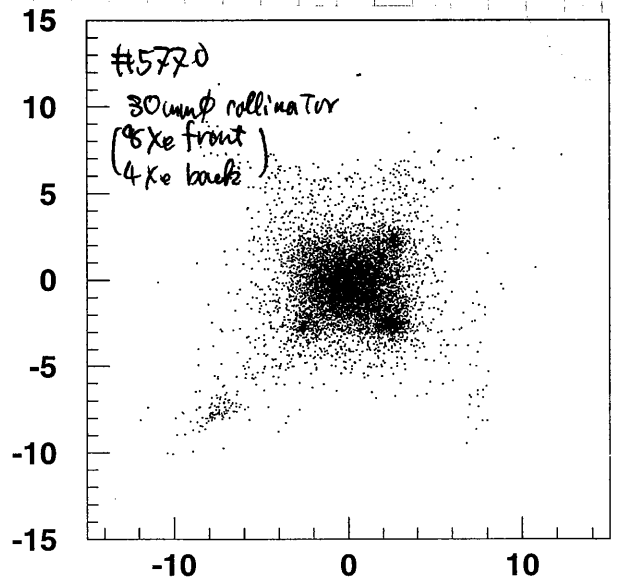
Y_AVERA VS. X_AVERA

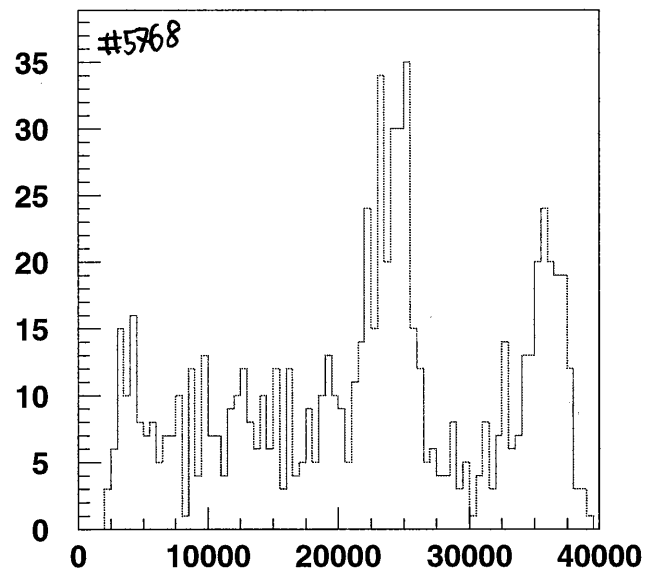
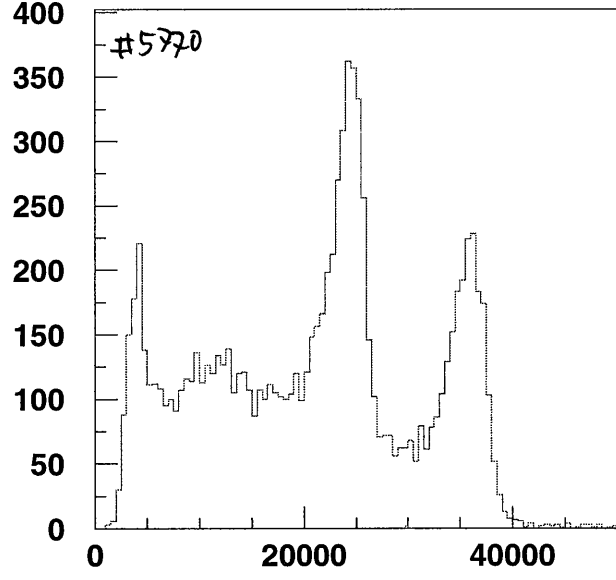
QSUM

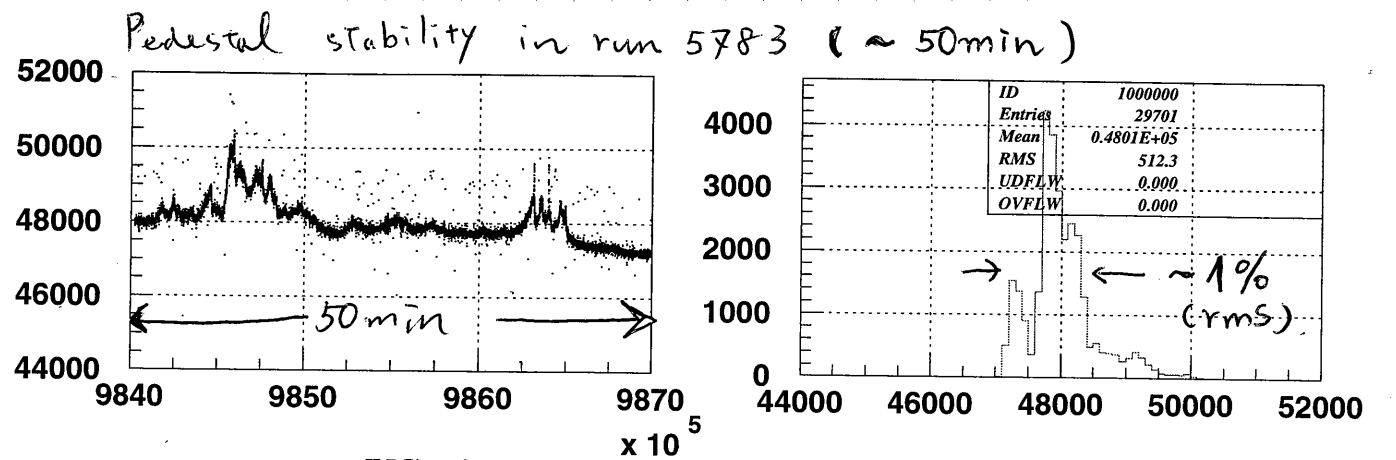
qsum VS. time

12:28 # 5784 CR run start w/ beam off & circ. off

60
2500

Qsym is not correlated with
(air conditions
chane operation)
Cold head temperature

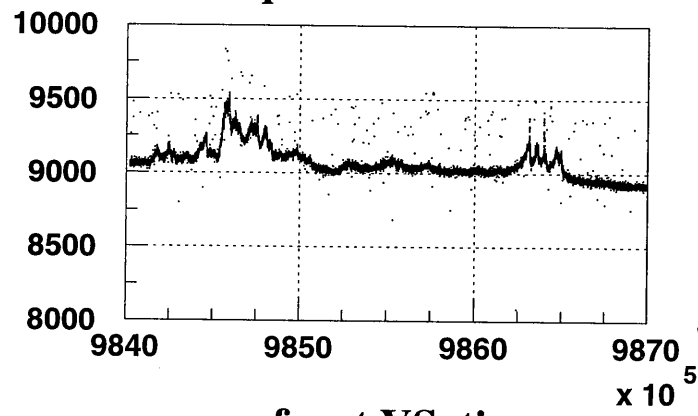
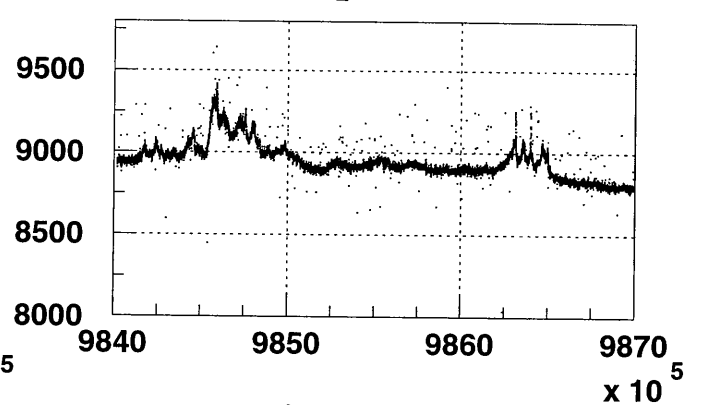
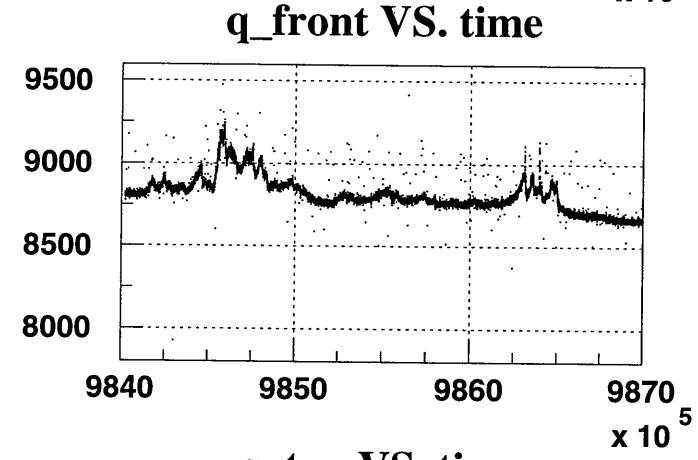
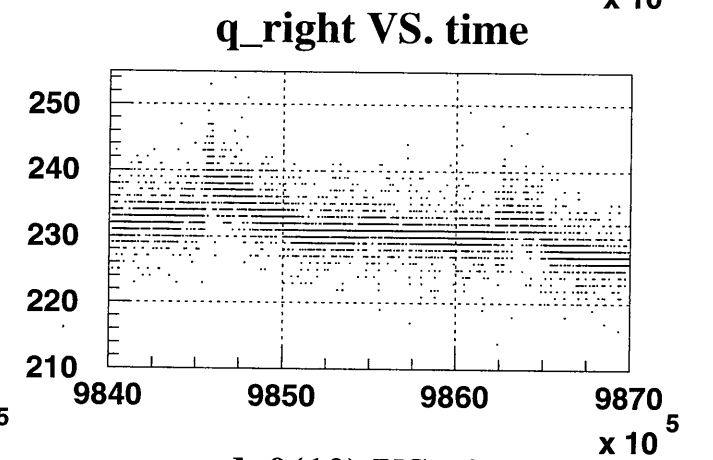
qsum

would be better to introduce pedestal trigger
